MINIMUM RECOMMENDED LAKE LEVELS: LAKE SANTA FE, FLORIDA

November 2022

Suwannee River Water Management District
9225 County Road 49
Live Oak, FL 32060

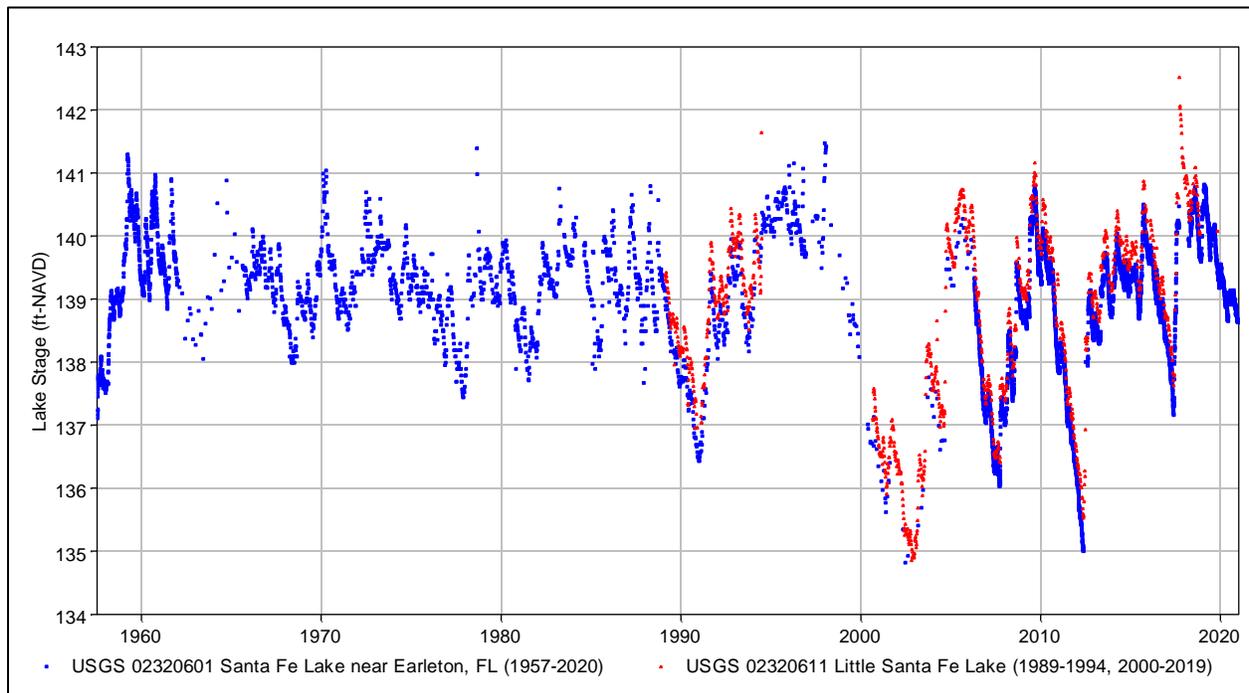
Figure 3-2. Observed Lake Stage Hydrographs at Lake Santa Fe (1957-2020).

As shown in Figure 3-2, the lake stage data collected at Little Lake Santa Fe has a big data gap in 1990's and the historical lake stage data at Lake Santa Fe was provided in a variety of frequencies.

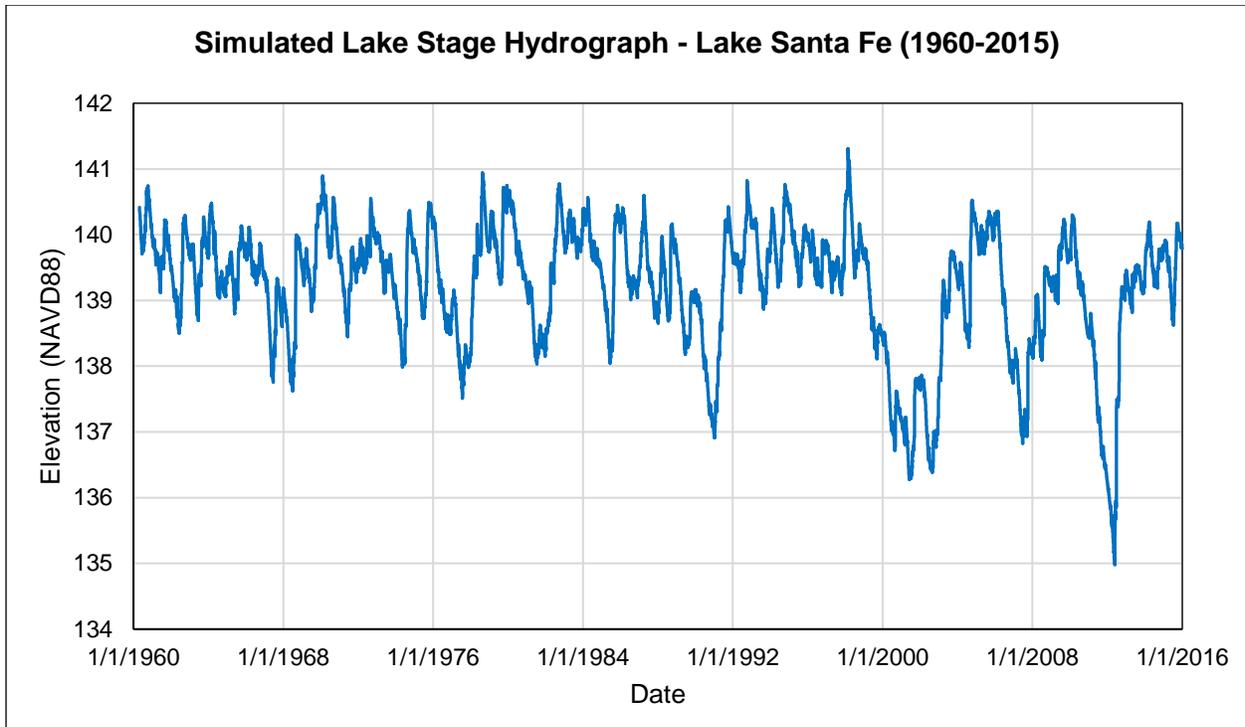
Figure 3-3. Hydrograph for Lake Santa Fe model simulated stage data for no-pumping scenario from 4/25/1960 to 12/31/2015.

Based on the daily model simulated lake stage data set for the no-pumping scenario (Figure 3-3), a stage exceedance graph was developed for Lake Santa Fe (Figure 3-4).

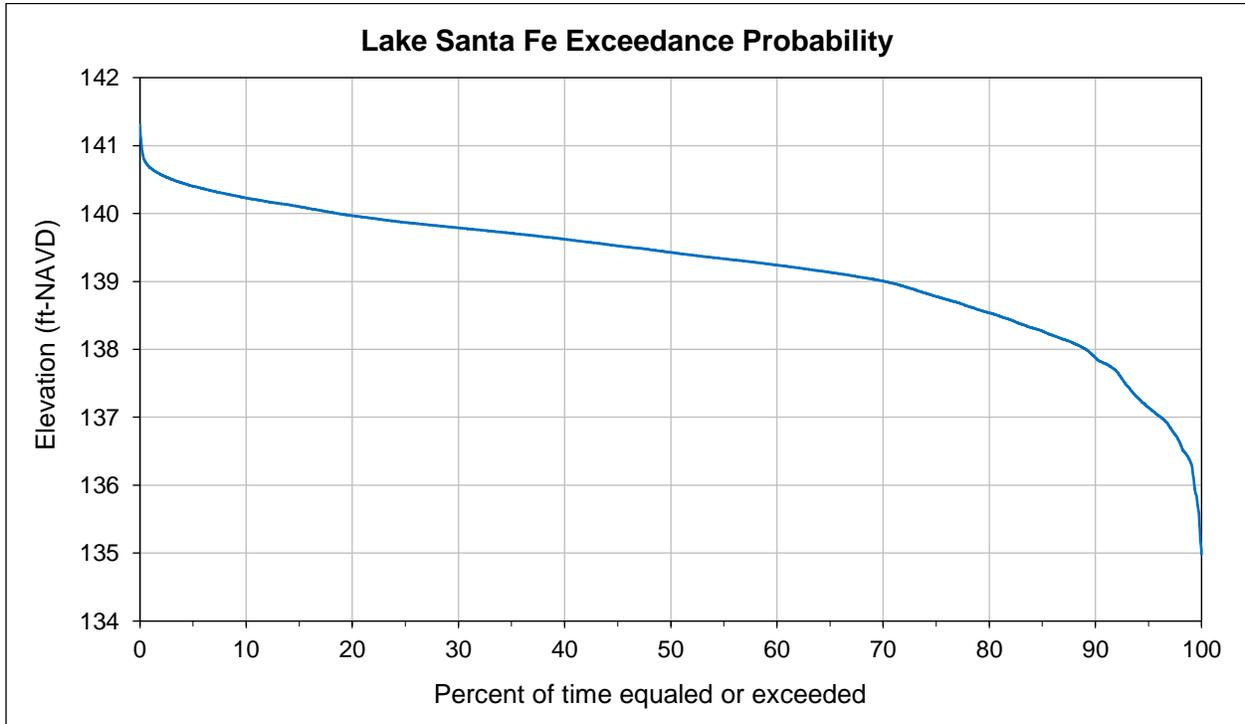
Figure 3-4. Stage Exceedance Graph for Lake Santa Fe model simulated stage data for no-pumping scenario from 4/25/1960 to 12/31/2015.

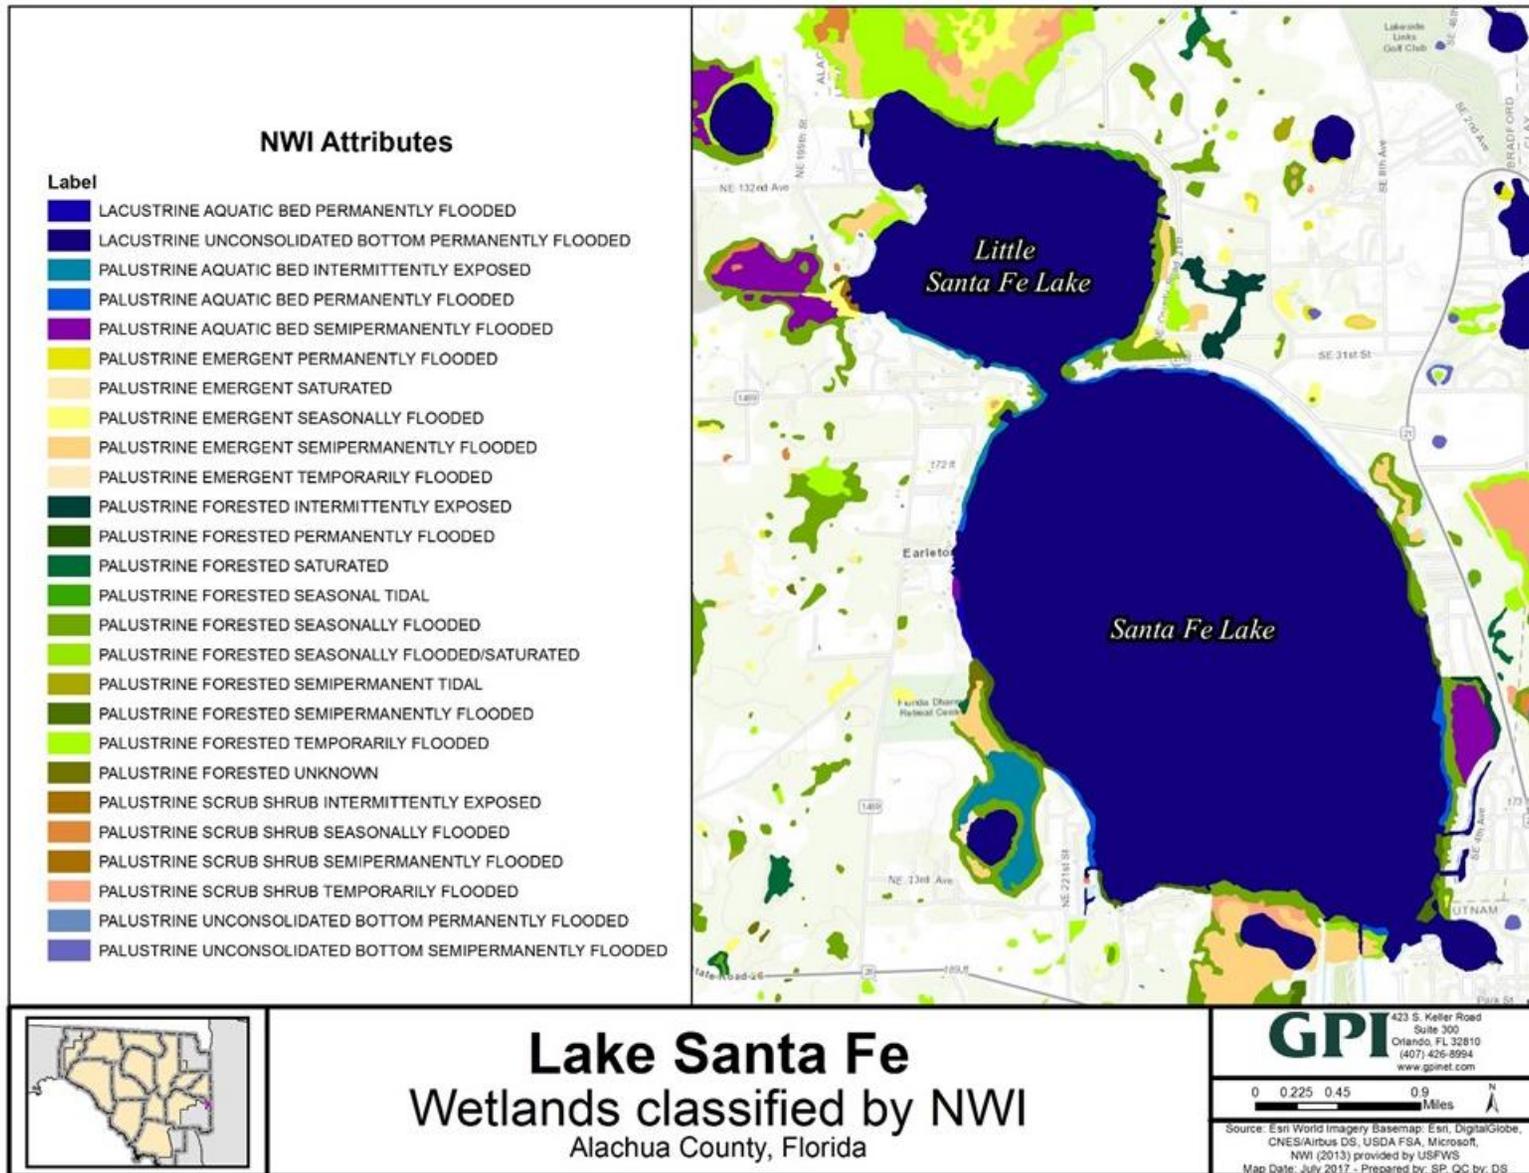
Figure 3-5. Wetlands classified by NWI near Lake Santa Fe (from GPI 2018).

The many types of forested wetlands presented as shades of green in Figure 3-5 characterize vegetation communities with deciduous trees represented by swamp tupelo (*Nyssa sylvatica* var. *biflora*), pond cypress (*Taxodium ascendens*), and red maple (*Acer rubrum*). Evergreens include loblolly bay (*Gordonia lasianthus*) and sweetbay magnolia (*Magnolia virginiana*). Darker shades in Figure 3-5 generally represent wetter water regimes. The wettest systems occur adjacent to the lake and also in some deeper basins in the backwater areas.

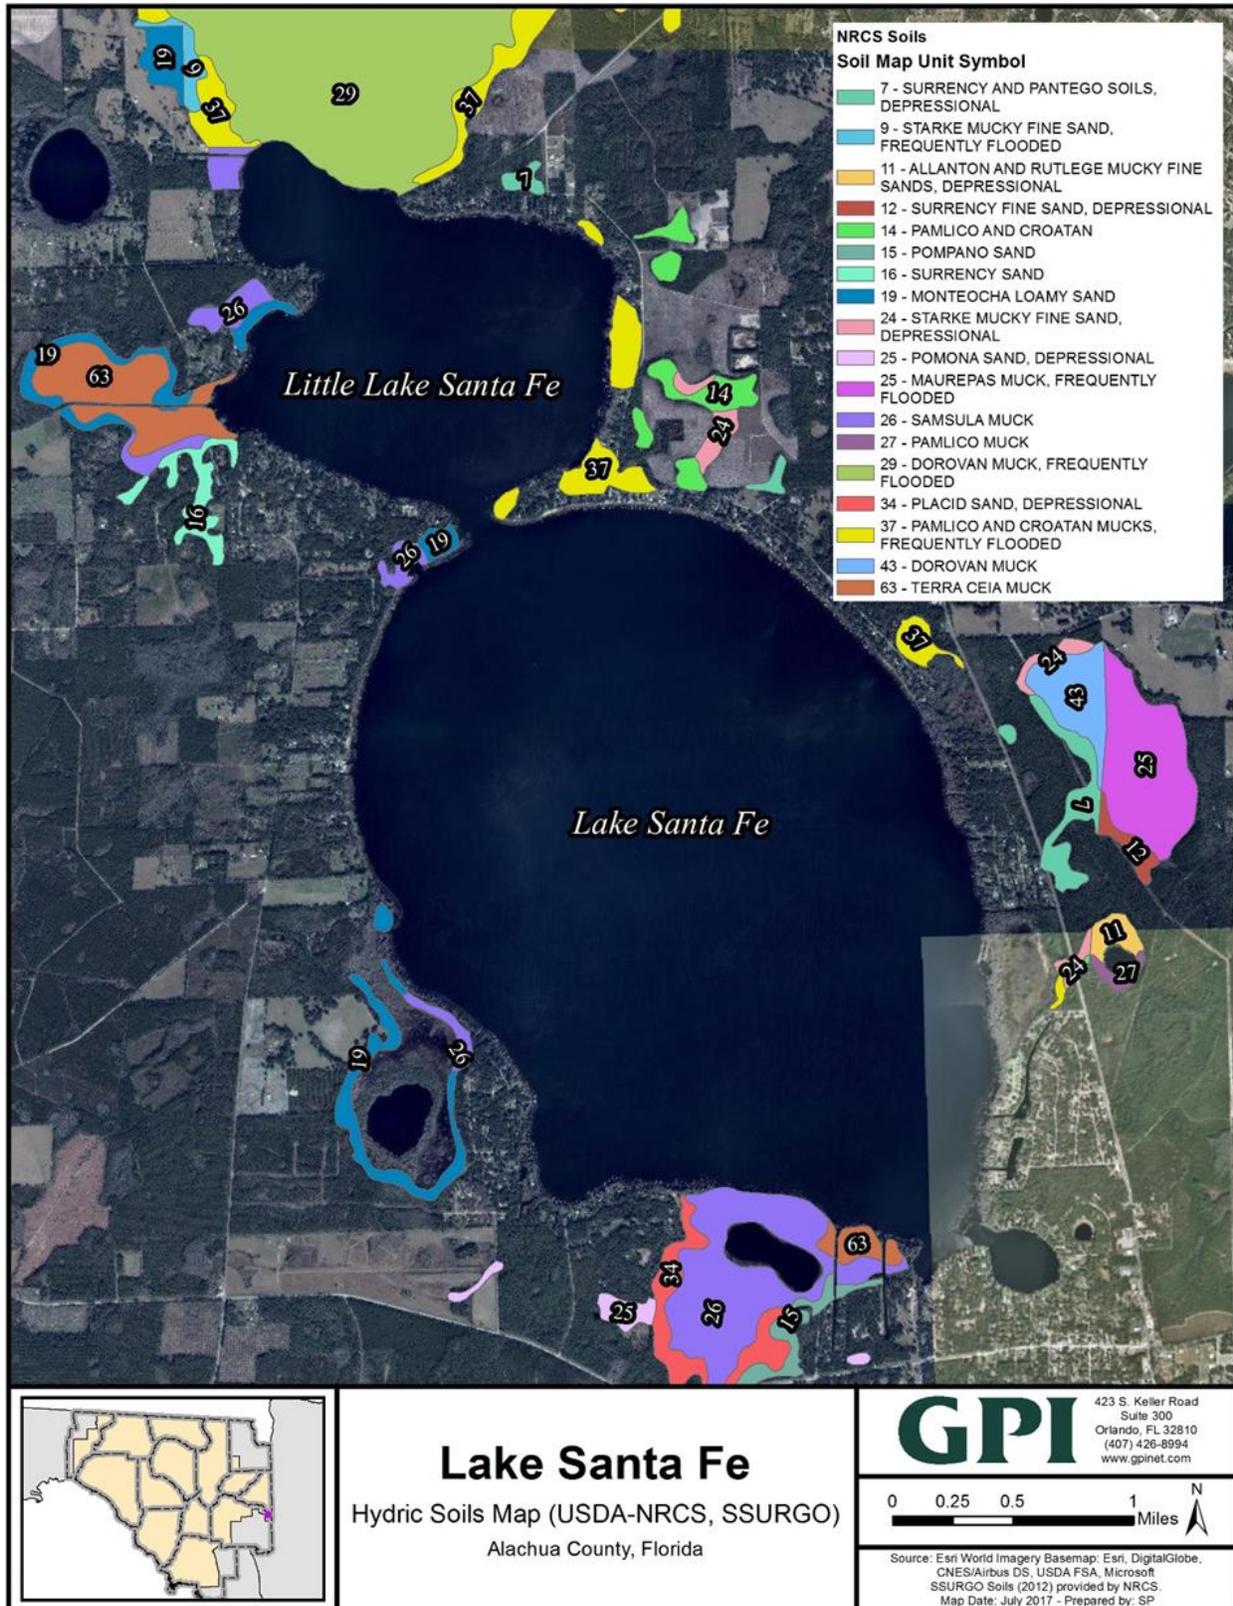
Figure 3-6. NRCS mapped soils near Lake Santa Fe (from GPI 2018).

Figure 3-6 depicts the hydric soils in proximity to Lake Santa Fe as designated by the USDA-NRCS Soil Survey Geographic database (SSURGO; Soil Survey Staff 2016). Individual map units are described in the legend according to texture, organic matter content, hydrologic regime, and relative elevation. The USDA-NRCS criteria for hydric soils are used in Florida State Standards under Rule 62-340.550, F.A.C. Under Florida State methodology, wetland hydrology is met when soils are inundated for a period of seven consecutive days and/or saturated for at least 20 consecutive days, during conditions which represent long-term hydrologic conditions. As defined, hydric soils are soils that are saturated, flooded, or ponded long enough during the growing season to develop anaerobic conditions in the upper part of the soil profile (Rule 62-340, F.A.C.). These soils support a prevalence of vegetation typically adapted for life in saturated environments.

The USDA-NRCS mapped most areas adjacent to Lake Santa Fe as upland soils (not shown on Figure 3-6). There are over 83 soil map units within a one-mile buffer of the lake. The somewhat poorly drained Lochloosa fine sand and excessively drained Penny sand and Penny fine sand make up about one third of these upland soils. They formed on nearly level to sloping landscapes in thick beds of eolian or marine deposits on knolls and terraces above the lake. About 21 percent of land area within the 1,000-ft lake buffer is dominated by Lochloosa fine sand. These upland soils are somewhat poorly drained mineral soils. Sapelo sands covering over 12 percent of the lake buffer are mineral soils that range from poorly drained to somewhat poorly drained. These two soils have a seasonal high saturation ranging from 6 to 18 inches below ground surface and are not considered hydric, with organic matter content of the surface horizons typically 5 percent or less.

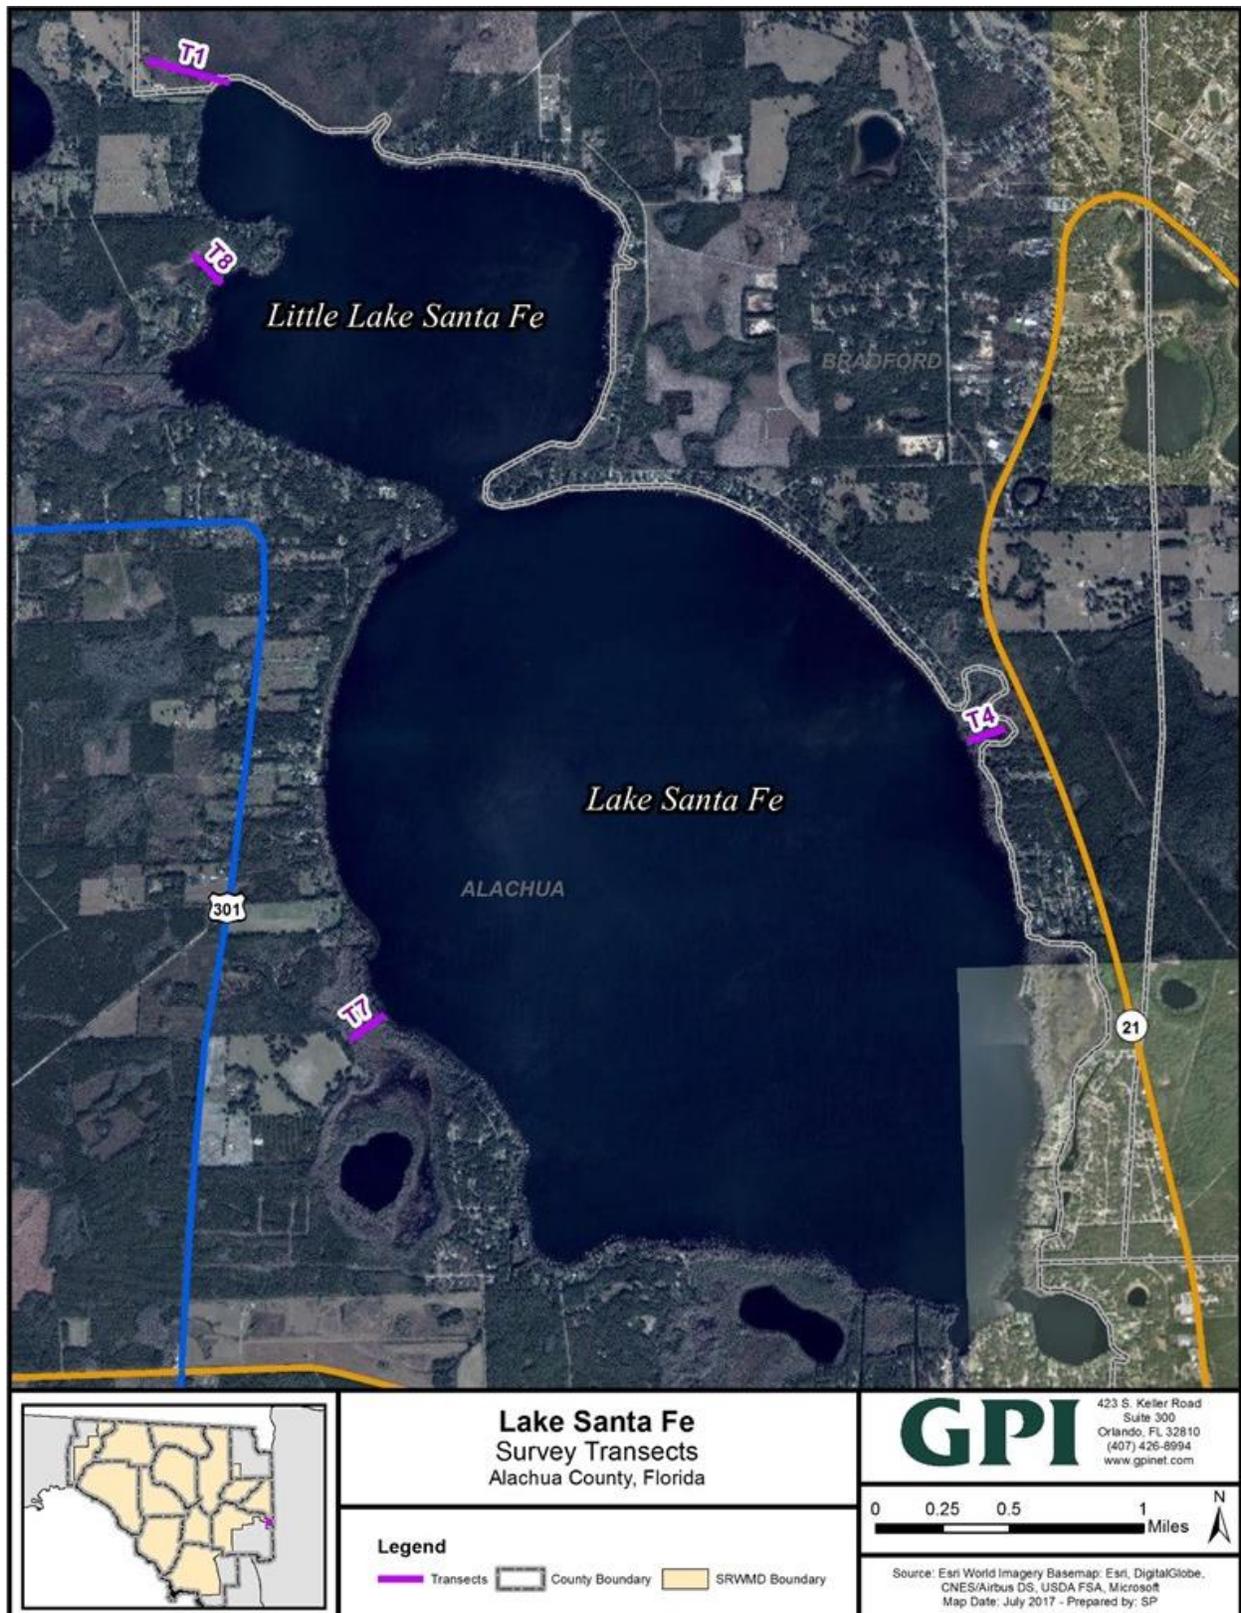
Figure 4-1. Lake Santa Fe sampling transect locations (from GPI 2018).

Lake Santa Fe transects were fixed routes, extending from open water to uplands. Elevation, vegetation, and soils data were sampled along the transects to characterize the influence of surface water flooding on the distribution of plant communities and soils. Figure 4-1 illustrates transect locations, each oriented perpendicular to the lake shoreline and extending from the open water to the uplands.

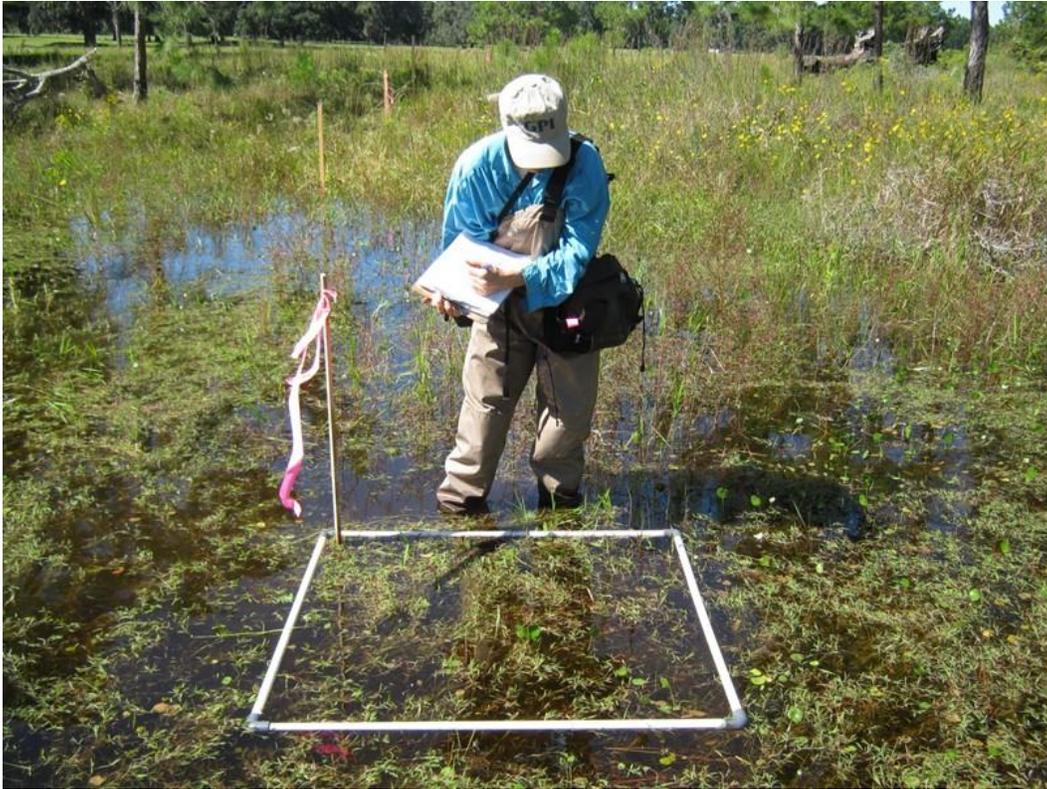
Figure 4-2. Transect 1: Herbaceous vegetation cover determination in a one-meter square quadrat. Survey stakes and measuring tape mark the transect centerline.

- Field identification of plant communities along sampling transects (Figure 4-2) using descriptions provided by Kinser (1996) and the FNAI Guide to the Natural Communities of Florida (FNAI 2010);
- Field determination of the boundaries of all plant communities identified along sampling transects; and
- Field collection of plant community data using quadrats (Figure 4-2), belt transects, and the point-centered quarter method (Cottam and Curtis 1956) in order to describe species composition of the plant communities.

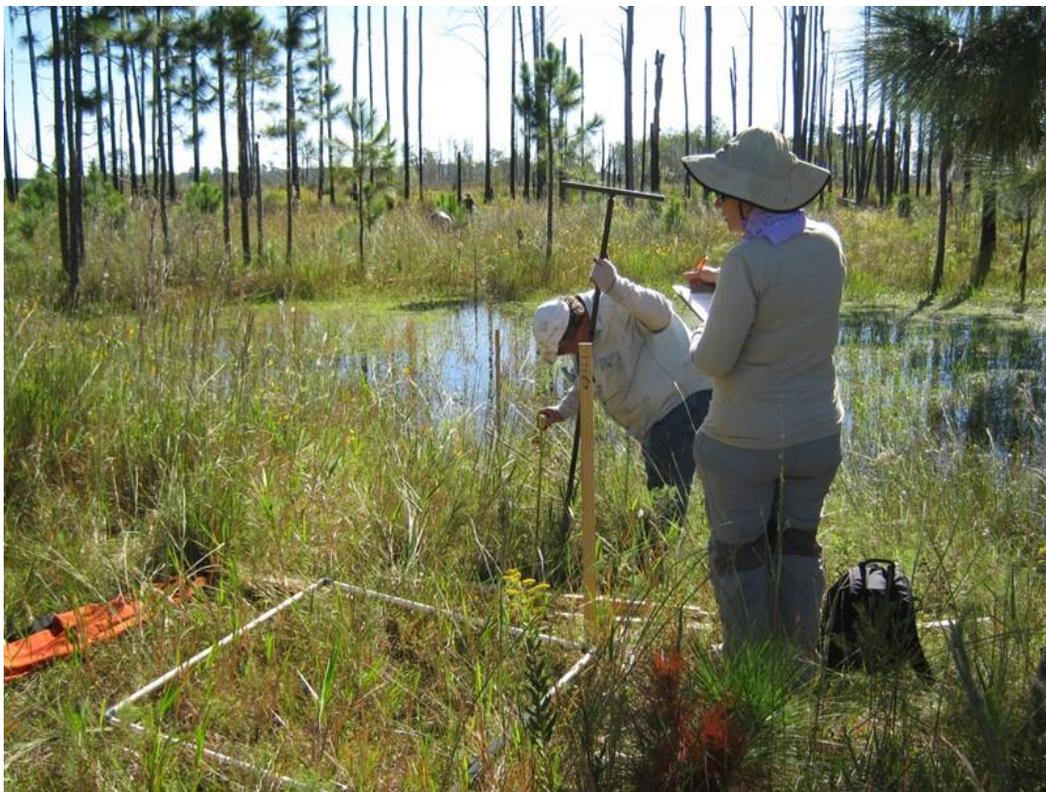
Figure 4-3. Transect 1: Soil characterization using an auger.

Detailed soil sampling procedures are presented in Appendix C of this report. Soil profiles were excavated along transects according to methods from the USDA-NRCS Field Book for Describing and Sampling Soils (Schoeneberger et al. 2012). This sampling effort targeted highly-organic soils that may be used in setting minimum average (MA) and minimum frequent low (FL) lake levels, according to event-based methods (SJRWMD 2006, Neubauer et al. 2008). These soils are classified as Histosols or exhibit the presence of a histic epipedon (USDA-NRCS 2016), and they were sampled from the wetlands using either a soil auger or probe to sufficient depth below soil surface for taxonomic confirmation (Figure 4-3). Sampling also was used to identify the landward extent of muck and the landward extent of hydric soils along the transect.

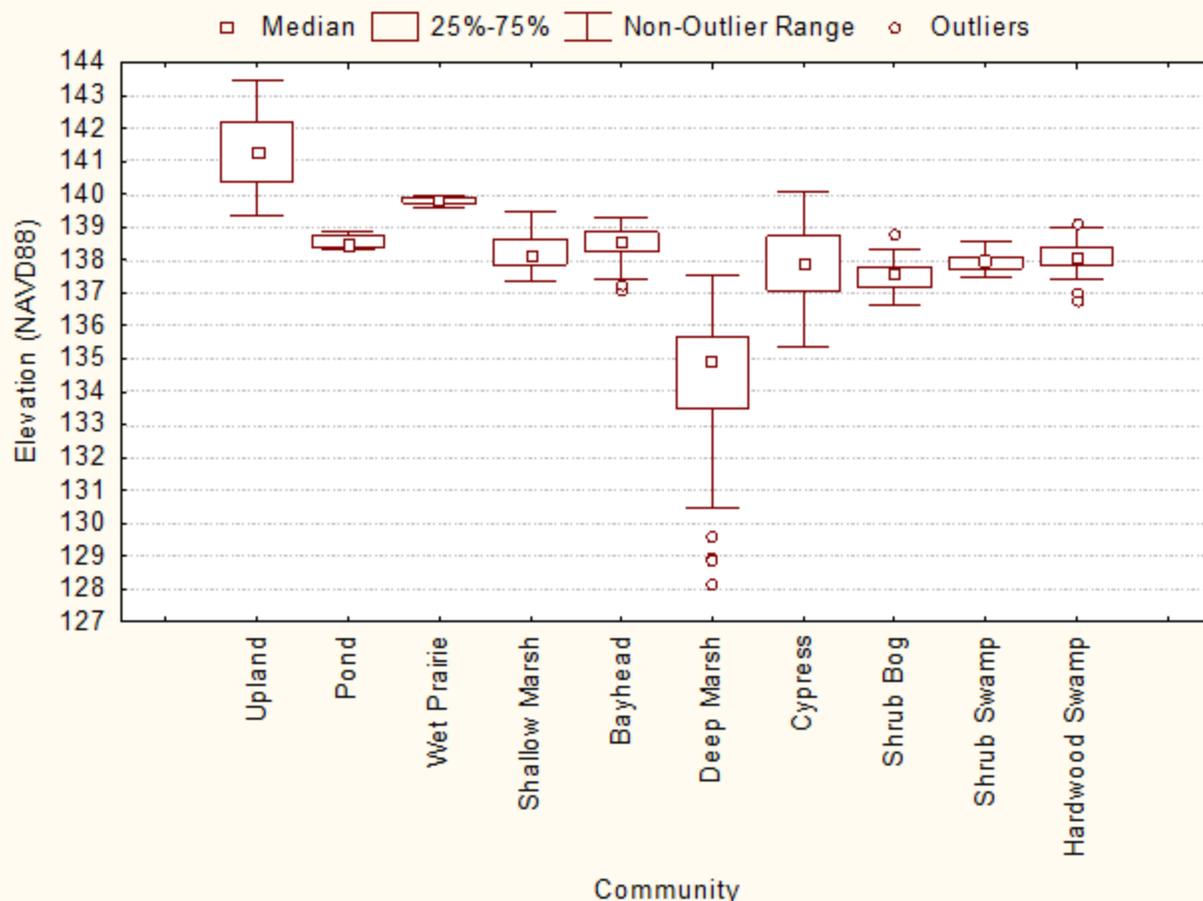
Figure 7-1. Distribution of elevations surveyed in Lake Santa Fe by community.

The lowest elevations sampled along the transects occurred in the deep marsh community, since those samples extended out into the lake in areas with emergent vegetation. The highest elevations were those landward ends of the transects described as upland. The rest of the wetland community types occurred between these extremes (Table 7-1 and Figure 7-1). There was very little overlap in elevation between upland areas and wetland areas as shown by the lack of overlap of the interquartile range of the upland samples over any of the wetland communities. As expected, wet prairie was the highest, and therefore driest, wetland community, which is generally “inundated for a relatively short duration each year” (Kinser 1996). The remaining wetland community types had partially overlapping elevational ranges, occurring mostly in a band between 137 and 139 ft NAVD88 (Figure 7-1). The deep mash community showed the widest elevation range, followed by the cypress community which had some large diameter cypress trees occurring in relatively deep water in the emergent zone of the lake and others occurring at elevations that were considered upland on some transects.

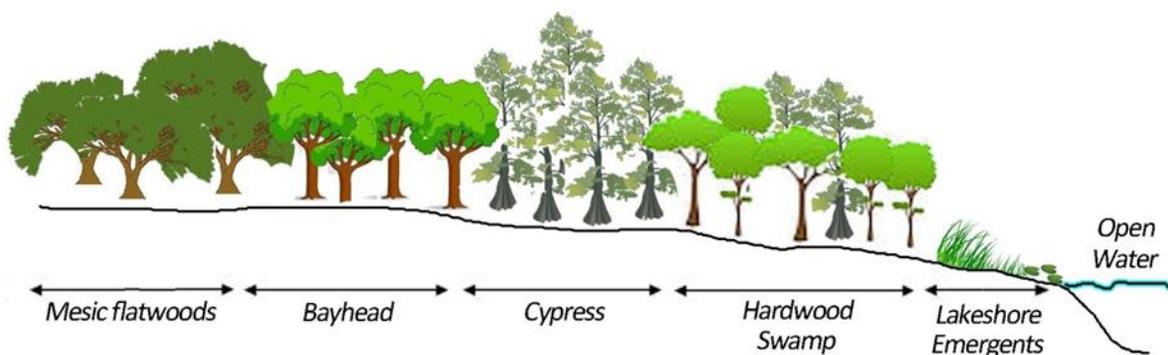
Figure B-1. Cross-section of a typical belt transect through forested and herbaceous plant communities described by Kinser (1996).

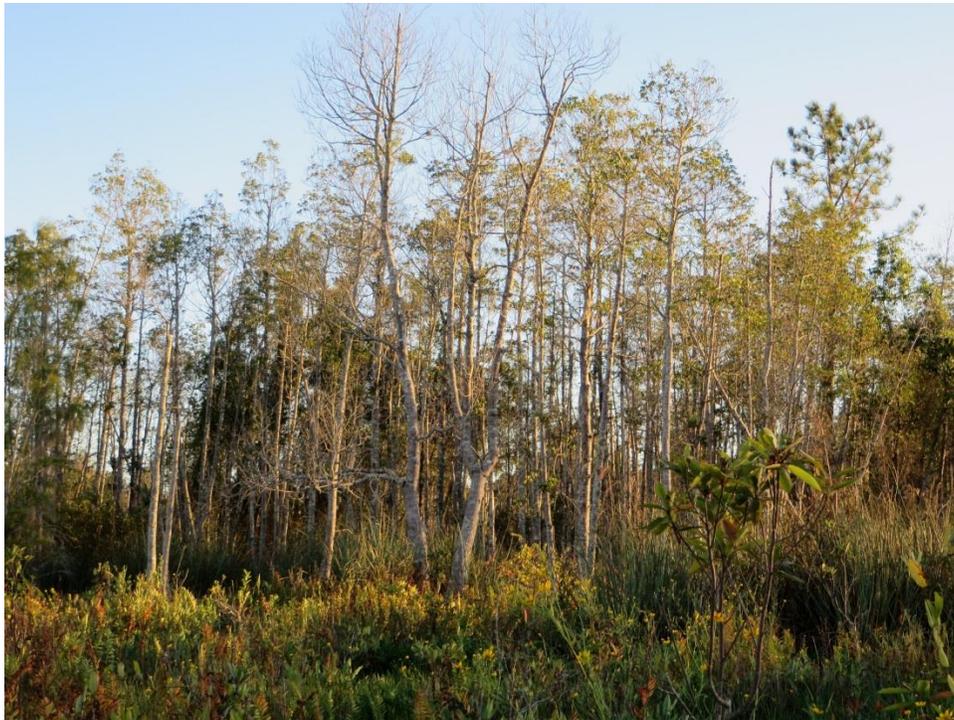
Figure B-2. Photo of bayhead habitat on Transect 1 in Lake Santa Fe.

The bayhead community was sampled along two transects in Lake Santa Fe (T1 and T8). As shown in Tables B-1 and B-2, the bayhead community canopy in Lake Santa Fe was dominated by loblolly bay (*Gordonia lasianthus*) and dahoon holly (*Ilex cassine*), with less frequent occurrences of fetterbush (*Lyonia lucida*), sweetbay (*Magnolia virginiana*), and blackgum (*Nyssa sylvatica* var. *biflora*). Juvenile loblolly bay were the most common shrub species (relative frequency of 25.00%, Table B-3); other mid-story and shrub species included Virginia willow (*Itea virginica*), juvenile sweetbay, and wax myrtle (*Morella cerifera*), with small amounts of swamp loosestrife (*Decodon verticillatus*), swamp doghobble (*Eubotrys racemosus*), juvenile dahoon holly, fetterbush, and juvenile blackgum. Tables B-1 and B-4 show that groundcover within the bayhead was very sparse, with burmarigold (*Bidens laevis*), Virginia chain fern (*Woodwardia virginica*) and broadleaf cattail (*Typha latifolia*) locally abundant in open areas, and the floating plant water spangles (*Salvinia minima*) was common in open areas with deeper standing water.

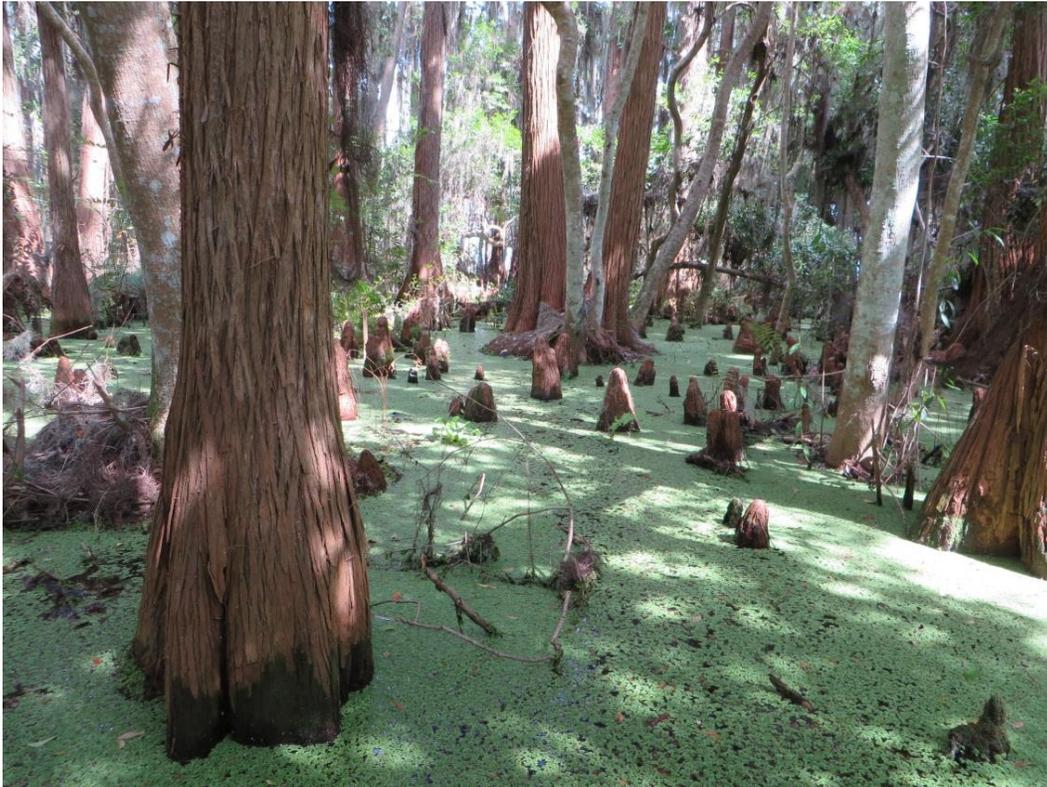
Figure B-3. Photo of cypress habitat on Transect 7 in Lake Santa Fe.

The cypress community was sampled along three transects in Lake Santa Fe (T4, T7, and T8). The cypress community canopy in Lake Santa Fe was dominated by pond cypress (*Taxodium ascendens*), with less frequent occurrences of dahoon holly and blackgum, and a few scattered individuals of red maple (*Acer rubrum*), sweetbay, Carolina willow (*Salix caroliniana*), and loblolly bay (Tables B-1 and B-2). Juvenile dahoon holly and Virginia willow were the most common shrub species (relative frequencies of 32.56 percent and 25.58 percent, respectively, Table B-3); other mid-story and shrub species included common buttonbush (*Cephalanthus occidentalis*), wax myrtle, juvenile red maple, juvenile blackgum, juvenile swamp bay (*Persea palustris*), and juvenile pond cypress. Most of the cypress community was densely shaded and covered with standing water, with water spangles the most common understory plant (Table B-1). Table B-4 shows a mean cover of 20.0 percent for open water, 14.1 percent for water spangles, and 13.5 percent for duckweed (*Lemna minor*), a smaller floating plant that is less easily visible. Virginia chain fern was common on the higher hummocks, but at low cover (4.0 percent), with maidencane (*Panicum hemitomon*) throughout at 4.9 percent cover.

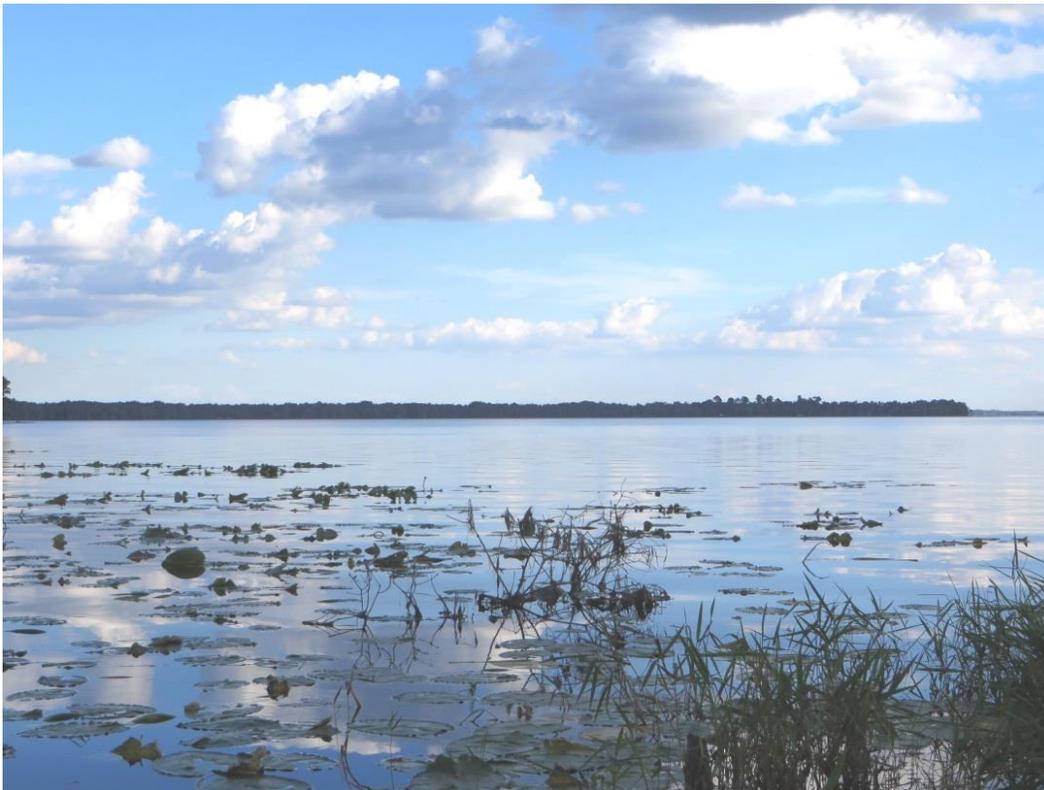
Figure B-4. Photo of deep marsh habitat on Transect 1 in Lake Santa Fe.

The deep marsh community was sampled along all four transects in Lake Santa Fe. The deep marsh canopy in Lake Santa Fe generally included large dbh, widely-spaced pond cypress, with frequent occurrences of blackgum and red maple, and occasional dahoon holly, wax myrtle, and Carolina ash (*Fraxinus caroliniana*) (Tables B-1 and B-2). Common buttonbush was the most common shrub species (relative frequency of 31.25 percent, Table B-3); with juvenile dahoon holly and sweetbay almost as frequent. Other mid-story and shrub species included Virginia willow, Mexican primrosewillow (*Ludwigia octovalvis*), juvenile blackgum, and elderberry (*Sambucus nigra* subsp. *canadensis*). Common emergent aquatic or floating plants included American cupscale (*Sacciolepis striata*) at 11.7 percent cover, mixed with large patches of spatterdock (*Nuphar advena*) (10.3 percent cover), maidencane (5.8 percent cover) and water spangles (16.6 percent cover) (Tables B-1 and B-4). Climbing hempvine (*Mikania scandens*) was abundant on shrubs at the upper edge of the community (15.6 percent cover).

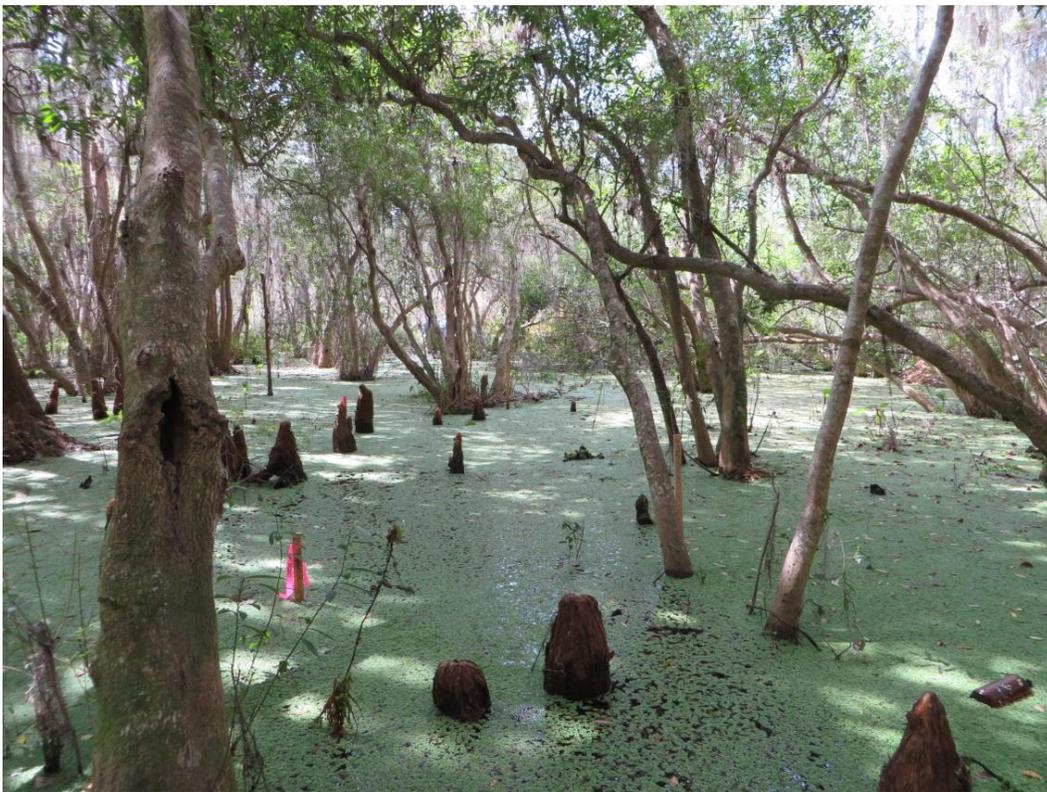
Figure B-5. Photo of hardwood swamp habitat on Transect 7 in Lake Santa Fe.

The hardwood swamp community was sampled along two transects in Lake Santa Fe (T7 and T8). The hardwood swamp canopy in Lake Santa Fe was largely dominated by dahoon holly, with moderate occurrences of red maple and blackgum, and less frequent occurrences of myrtle dahoon (*Ilex cassine* var. *myrtifolia*), pond cypress, loblolly bay, wax myrtle, and common buttonbush (Tables B-1 and B-2). Virginia willow and juvenile dahoon holly were the most common shrub species (relative frequencies of 20.69 percent and 17.24 percent, respectively, Table B-3). Other mid-story and shrub species included swamp loosestrife, wax myrtle, fetterbush, common buttonbush, juvenile loblolly bay, juvenile myrtle dahoon, juvenile sweetbay, and highbush blueberry (*Vaccinium corymbosum*). Groundcover was sparse except for the floating plants water spangles (42.5 percent cover), duckweed (22.0 percent cover) and bladderwort (*Utricularia* sp.) (7.8 percent cover). A few other emergents were present at less than 5 percent cover each (Tables B-1 and B-4).

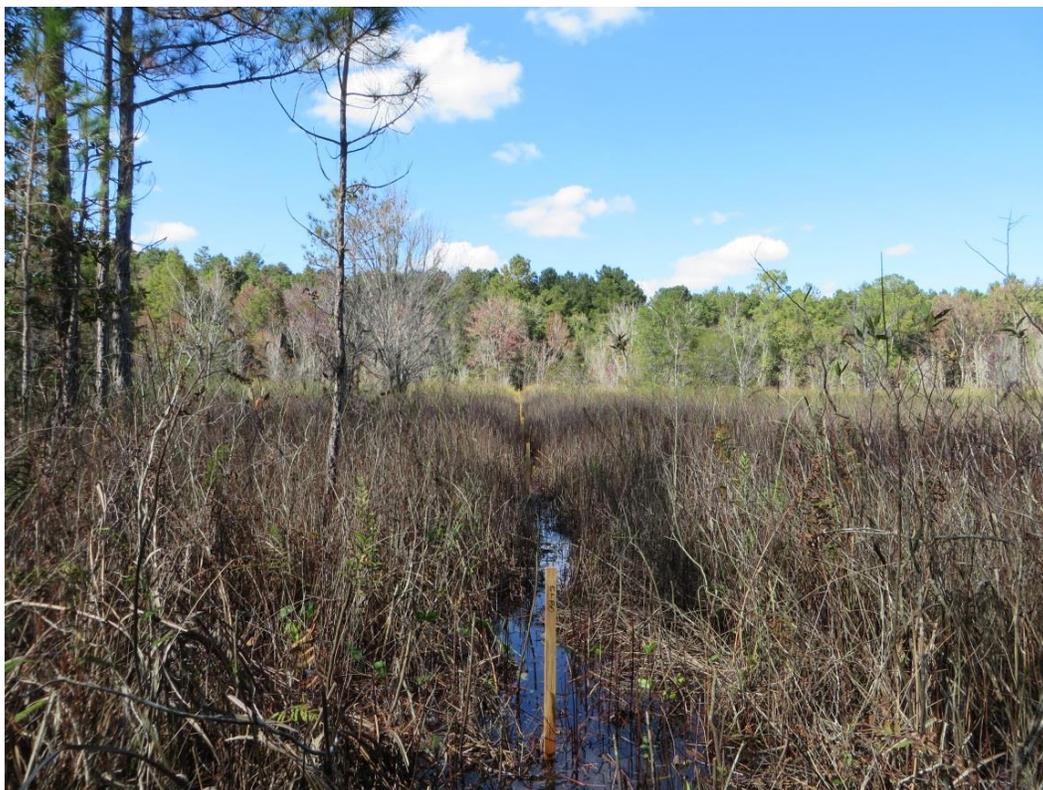
Figure B-6. Photo of shallow marsh habitat on transect 8 in Lake Santa Fe.

The shallow marsh community was sampled along three transects in Lake Santa Fe (T1, T4, and T8). The shallow marsh community of Lake Santa Fe had a very sparse cover of trees (less than 5

percent cover), which mostly consisted of red maple (Table B-1). Of the few trees present, blackgum, had the largest importance value (Table B-2). Smaller trees of red maple, slash pine (*Pinus elliottii*), and dahoon holly occurred around the fringes of the community, with scattered occurrences of common buttonbush and pond-cypress (Table B-2). Swamp loosestrife was the most common shrub species (relative frequency of 28.57 percent, Table B-3); other mid-story and shrub species included common buttonbush, Virginia willow, juvenile slash pine, juvenile red maple, Mexican primrosewillow, juvenile dahoon holly, and juvenile blackgum. The groundcover was very dense, with a mixture of plants. Green arrow arum (*Peltandra virginica*) was dominant along the transect that had recently experienced a severe fire, but it was at low cover on the other transects (6.3% cover overall). Other common plants were maidencane (16.8 percent cover), watershield (*Brasenia schreberi*) (14.0 percent cover), bladderwort (7.1 percent cover), pinebarren goldenrod (*Solidago fistulosa*) (7.0 percent cover), viviparous spikerush (*Eleocharis vivipara*) (5.5 percent cover), and Virginia chain fern (5.3 percent cover), with a variety of other emergents in smaller numbers and less than 5 percent cover each (Tables B-1 and B-4).

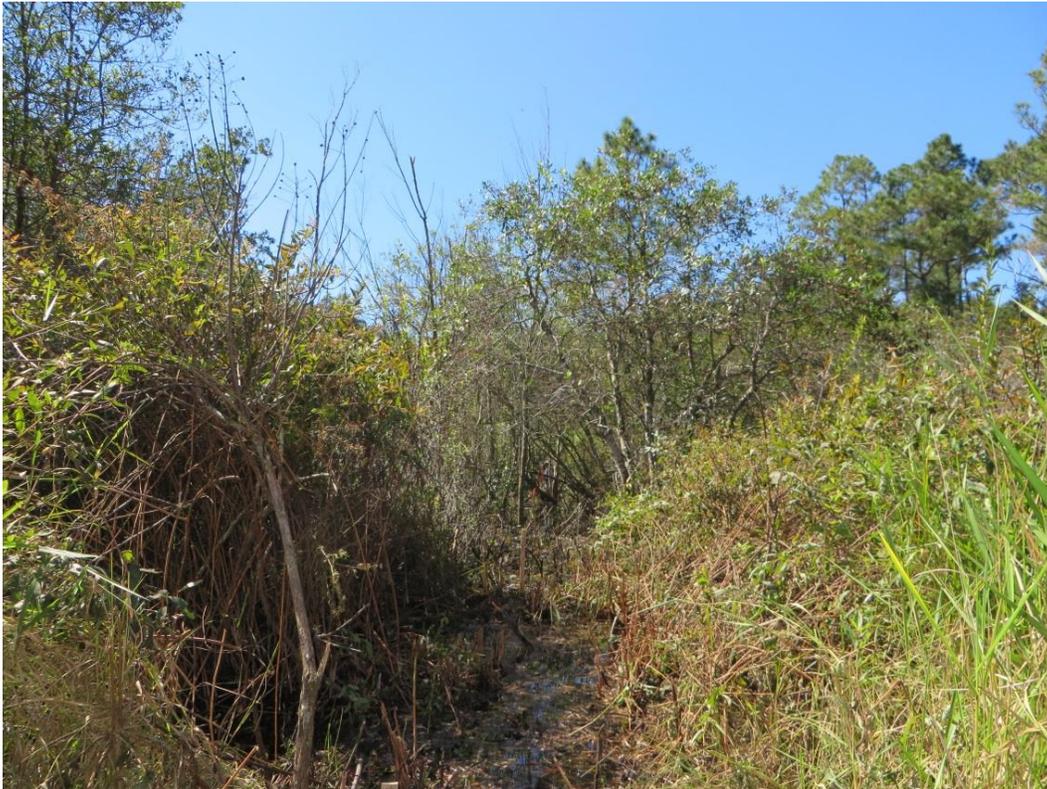
Figure B-7. Photo of shrub bog habitat on Transect 4 in Lake Santa Fe.

The shrub bog community was sampled along only one transect in Lake Santa Fe (T4). The shrub bog canopy of Lake Santa Fe was largely dominated by a dense cover of small dahoon holly trees, with

much less frequent occurrences of blackgum and red maple (Tables B-1 and B-2). Virginia willow was the most common shrub species (relative frequency of 50 percent, Table B-3); other mid-story and shrub species included juvenile dahoon holly and swamp loosestrife. There was very little groundcover because of the dense shrubs and small trees. Duckweed occurred at 39.0 percent cover in the standing water underneath the shrubs (Tables B-1 and B-4).

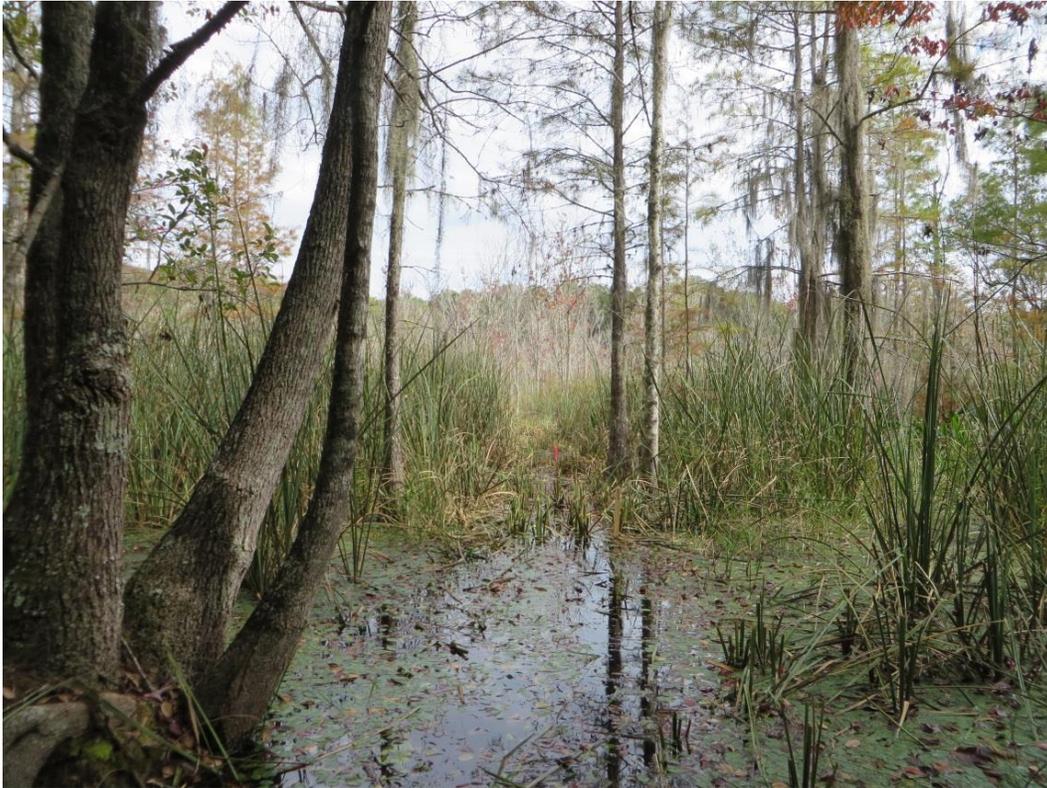
Figure B-8. Photo of shrub swamp habitat on Transect 7 in Lake Santa Fe.

The shrub swamp community was sampled along only one transect in Lake Santa Fe (T7). The shrub swamp canopy of Lake Santa Fe was largely dominated by many small widely-spaced red maple trees, with moderate occurrences of myrtle dahoon and blackgum, and less frequent occurrences of pond cypress (Tables B-1 and B-2). Common buttonbush was the most common shrub species (relative frequency of 40 percent, Table B-3); other mid-story and shrub species included Virginia willow, with smaller amounts of juvenile red maple, and juvenile dahoon holly. The emergent groundcover was dominated by watershield (29.0 percent cover) mixed with Jamaica swamp sawgrass (*Cladium jamaicense*) (8.5 percent cover) and green arrow arum (8.0 percent cover). The cover estimate for sawgrass was much lower in the quadrat data because the sawgrass was thin with many dead stalks. Water spangles grew densely underneath the thin sawgrass (40.1% cover) (Tables B-1 and B-4).

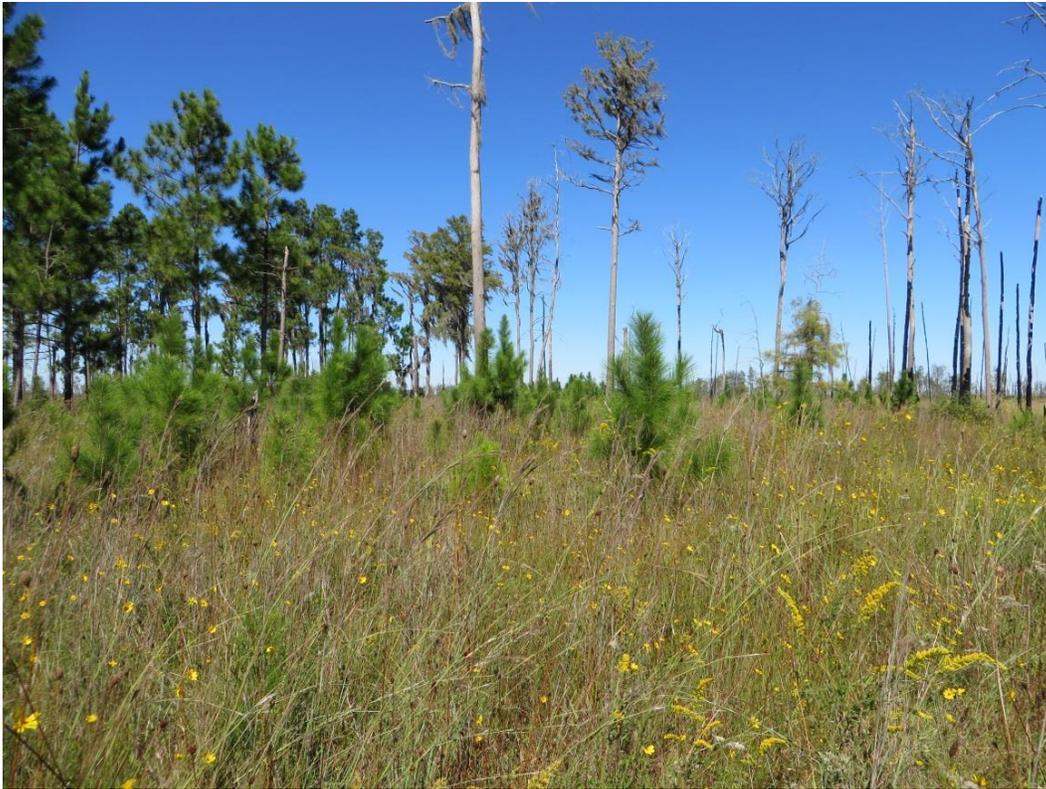
Figure B-9. Photo of wetland prairie habitat on Transect 1 in Lake Santa Fe.

The wetland prairie community was sampled along only one transect in Lake Santa Fe (T1). The only trees were slash pine at 5 to 25 percent cover, with large trees along the upper boundary, and juveniles further in the wetland. Slash pine was the most common shrub species (relative frequency of 66.67 percent, Table B-3), with juvenile pond cypress also present. The dense groundcover was dominated by beaksedge (*Rhynchospora* spp.) (24.6 percent cover) and purple bluestem (*Andropogon glomeratus* var. *glaucoptis*) (17.9 percent cover) and, along with a wide variety of herbs (Tables B-1 and B-4).
