MINIMUM RECOMMENDED LAKE LEVELS: LAKE SANTA FE, FLORIDA

November 2022

Suwannee River Water Management District
9225 County Road 49
Live Oak, FL 32060

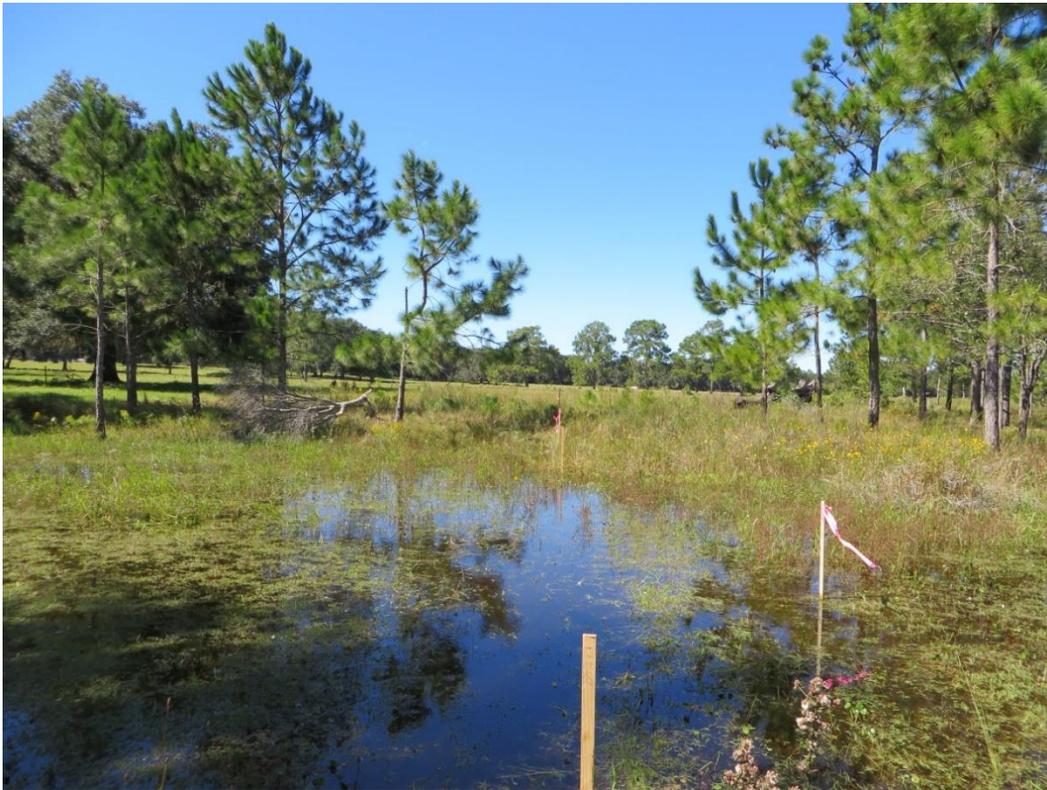
Figure B-10. Photo of pond habitat on Transect 1 in Lake Santa Fe.

The pond community was sampled along only one transect in Lake Santa Fe (T1). There were no PCQ vegetation data collected for the pond community due to its very small size. Southern watergrass (*Luziola fluitans*) was the dominant species at 60 percent cover, with creeping rush (*Juncus repens*) at 20.0 percent cover, marsh pennywort at 5.0 percent cover, and maidencane at 3.0 percent cover (Table B-4). There were no trees or shrubs present.

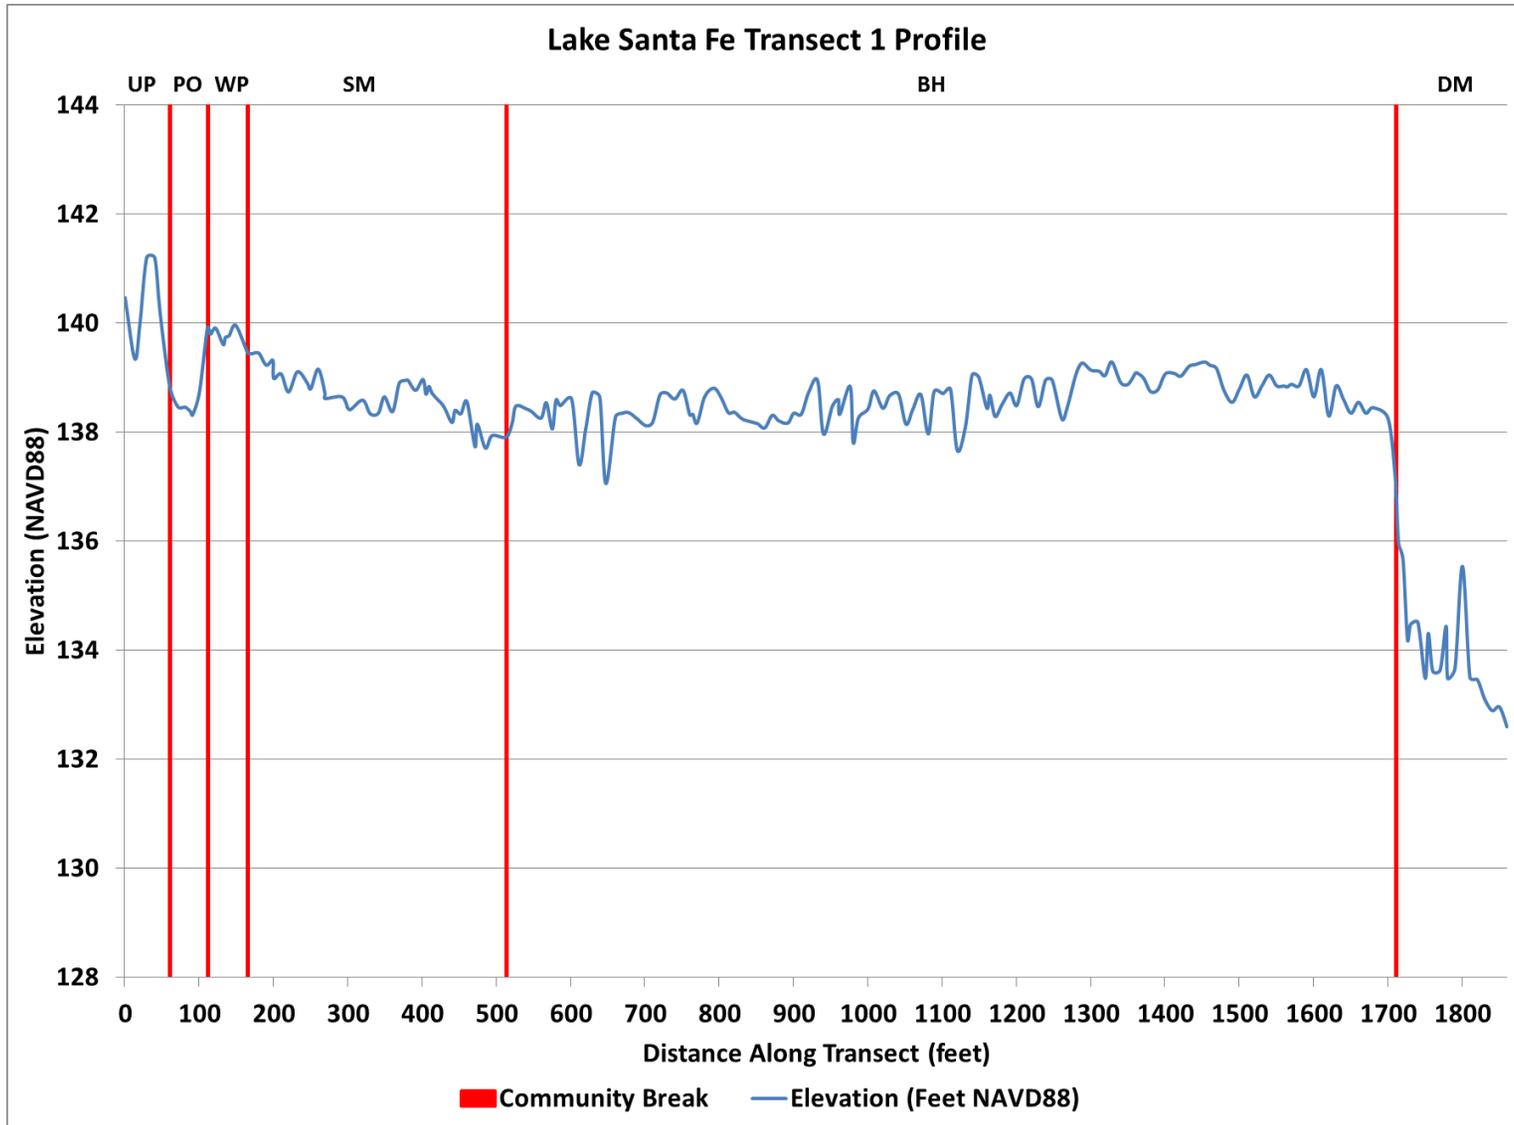
Figure B-11. Elevations along Transect 1, from the highest point surveyed in the uplands to the lowest point surveyed in the deep marsh.

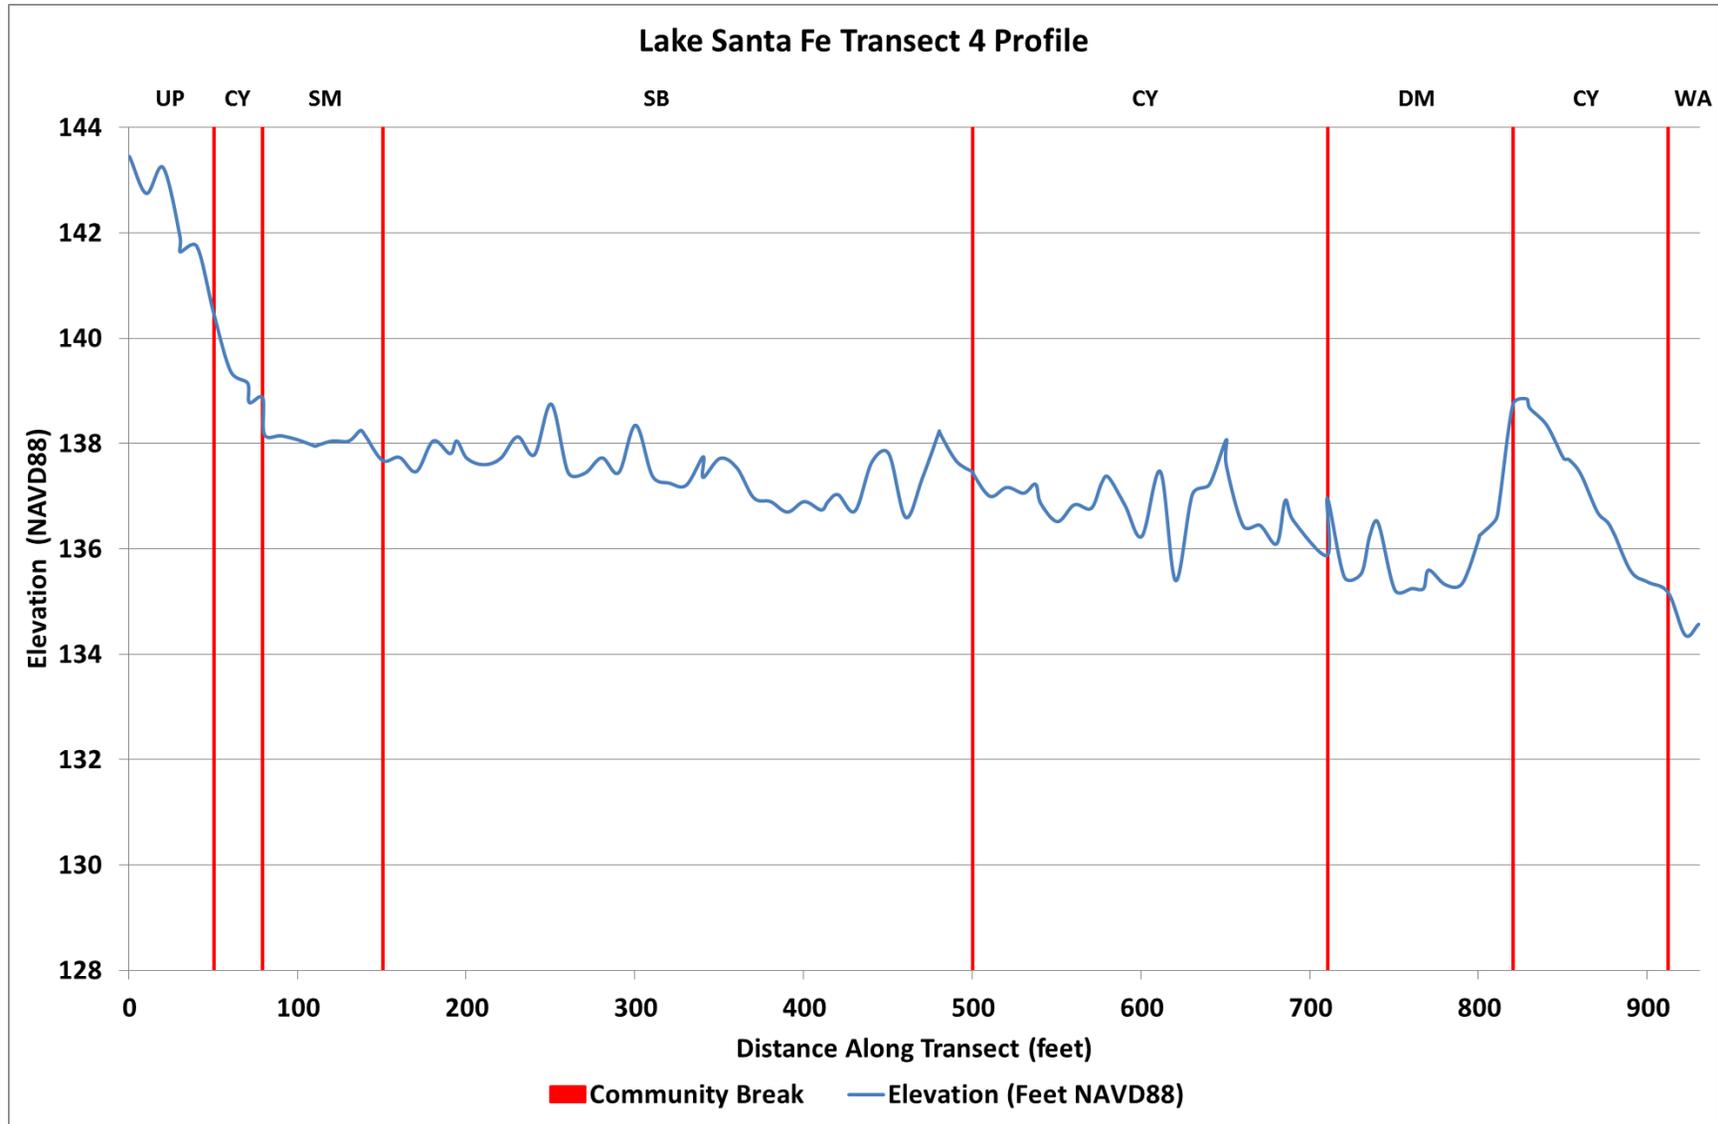
Figure B-12. Elevations along Transect 4, from the highest point surveyed in the uplands to the lowest point surveyed in the open water.

As shown in Figures B-12, B-13, and B-14, a total of six cypress communities was observed on three of the four studied transects. The mean ground surface elevations of the cypress communities (CY1 through CY6) are summarized in Table 7-2 in Section 7.1. The distribution of surface elevations in these cypress communities is shown in Figure B-15. Two of the six cypress communities are immediately adjacent to upland areas (Figures B-12 and B-13) with similar mean ground elevations of 139.10 ft NAVD88 (CY1) and 138.99 ft NAVD88 (CY4), which are relatively higher than other four cypress communities that are closer to the lake shoreline. Note that cypress communities adjacent to upland areas could be potentially influenced by the groundwater baseflow from their upland contributing areas.

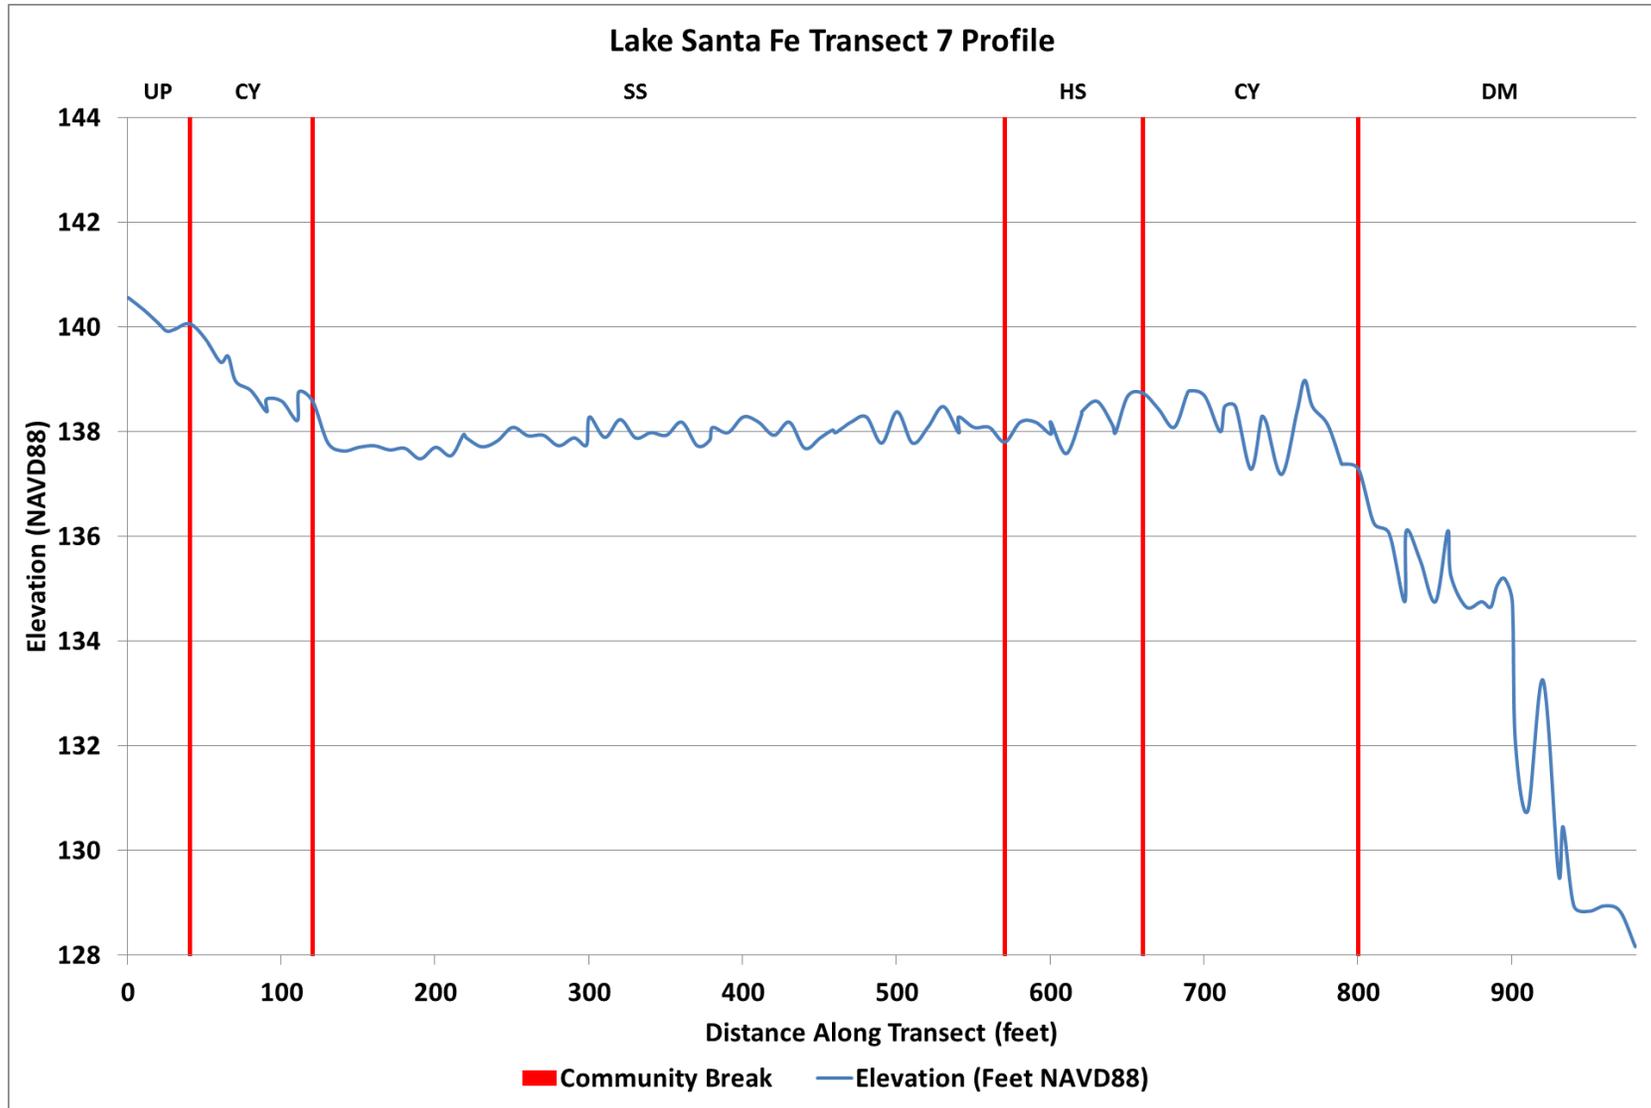
Figure B-13. Elevations along Transect 7, from the highest point surveyed in the uplands to the lowest point surveyed in the deep marsh.

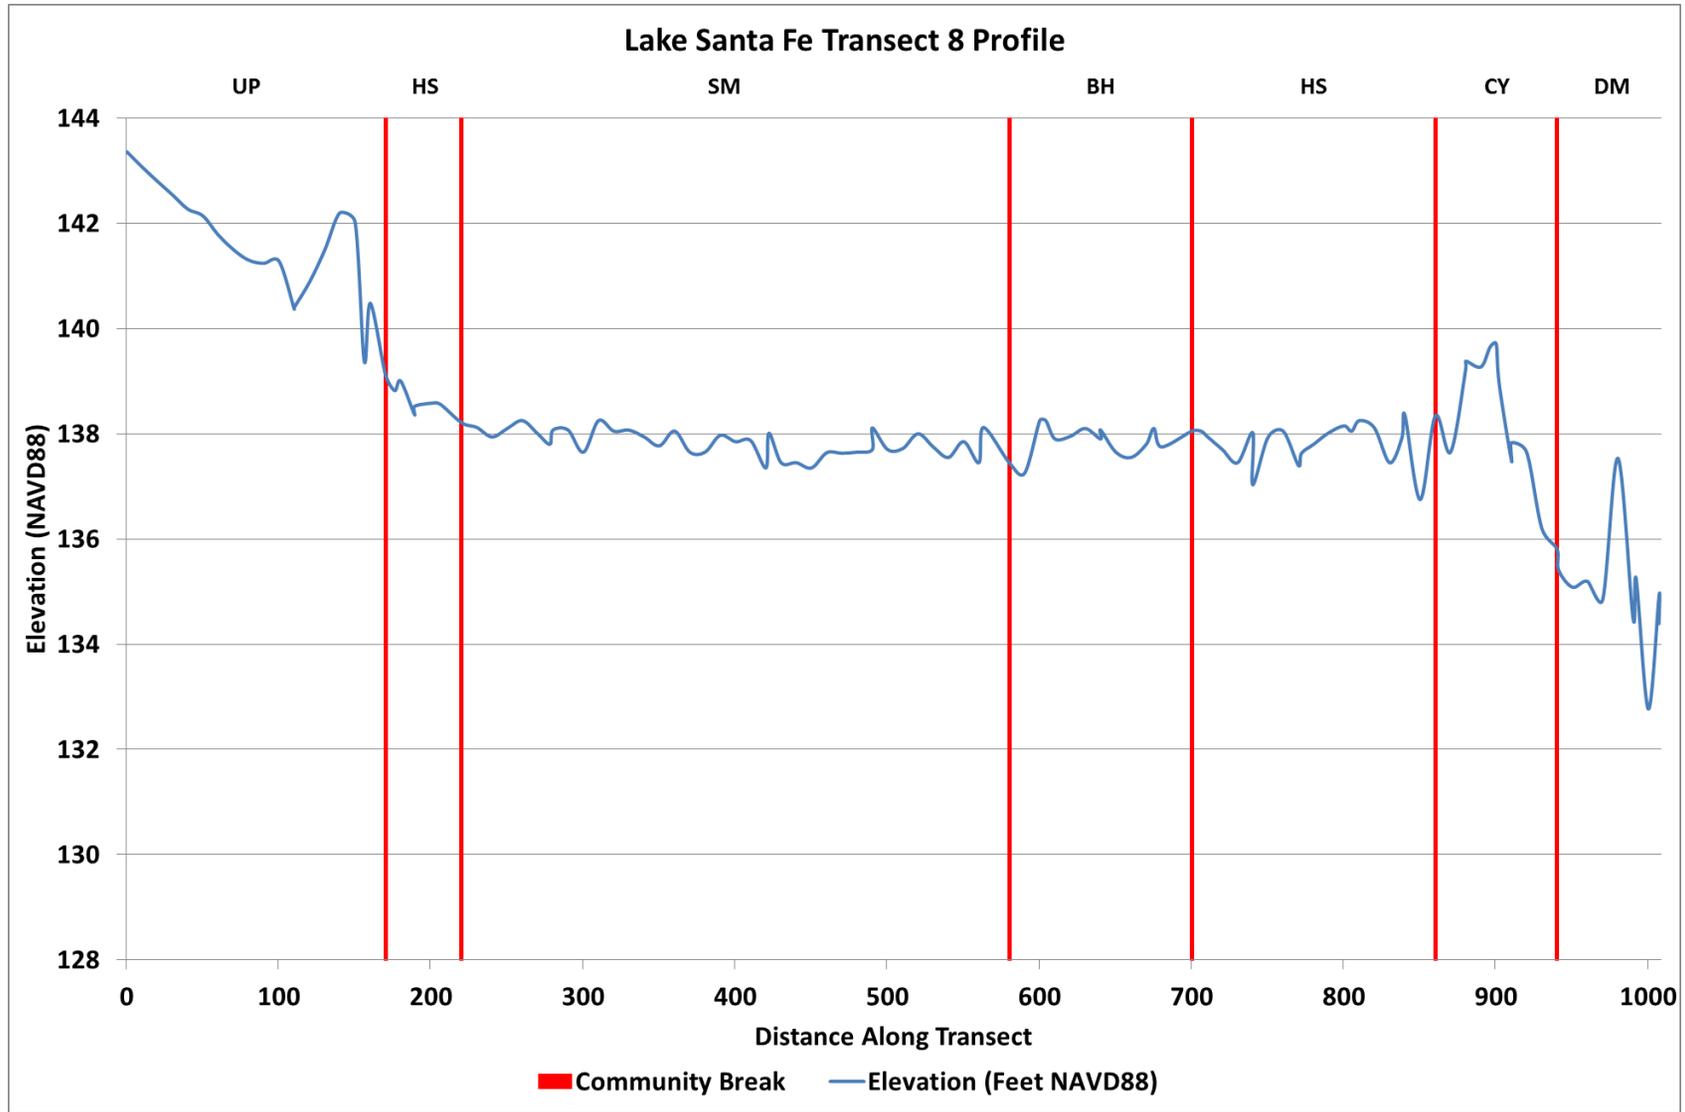
Figure B-14. Elevations along Transect 8, from the highest point surveyed in the uplands to the lowest point surveyed in the deep marsh.

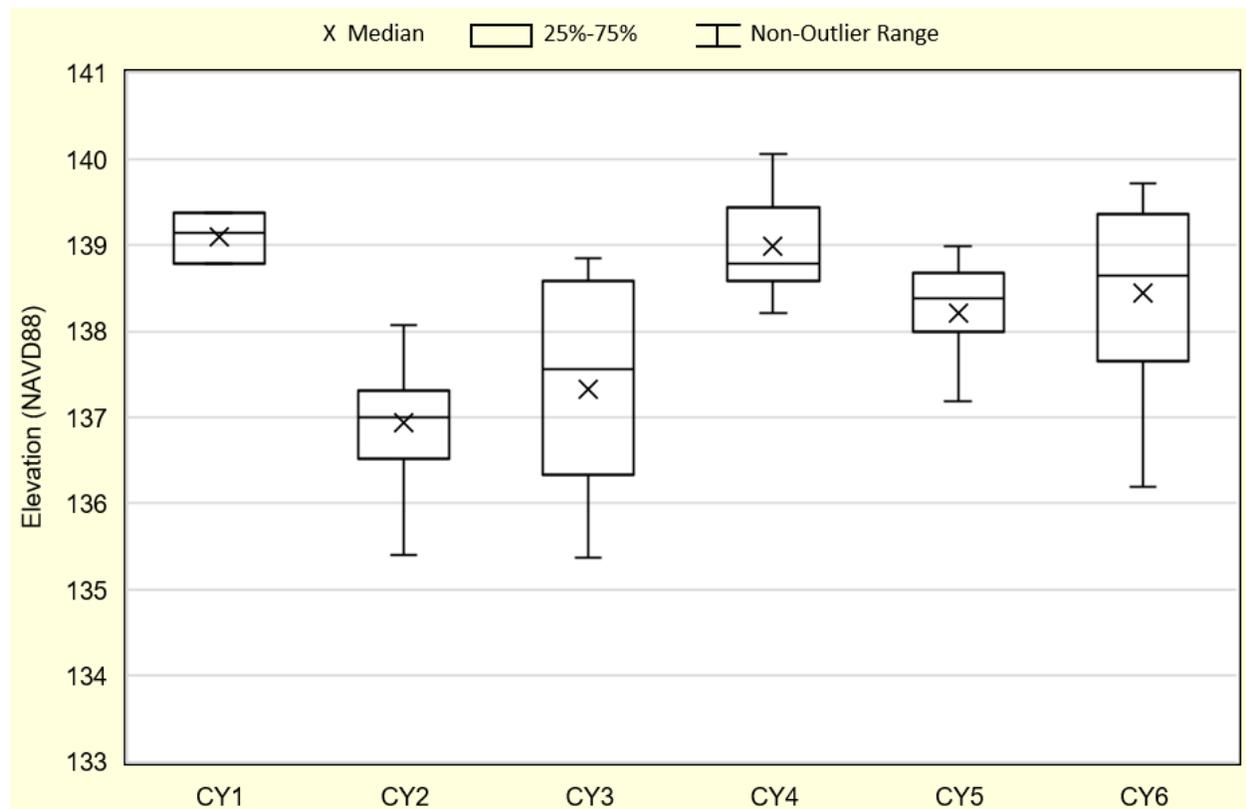
Figure B-15. Boxplot of surface elevations by cypress community.

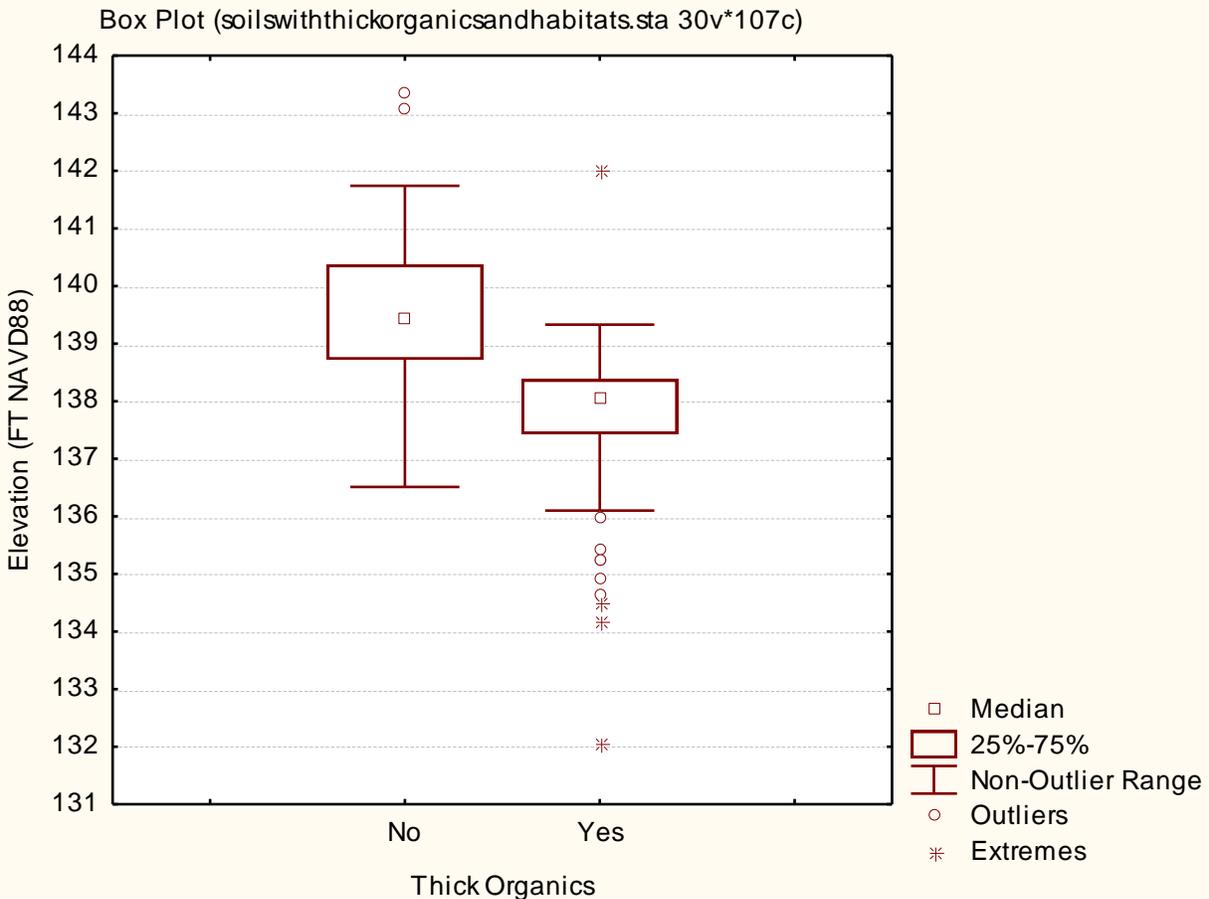
Figure C-1. Elevational distribution of soil borings with thick organics.

Considering all samples, there was some minor overlap in the elevations of samples with and without thick organics (Figure C-1). However, the difference in elevation of the two groups was statistically significant (Mann-Whitney U, $p < 0.001$); the median of the elevations with thick organics (138.04 ft NAVD88, $n=82$) was less than the median of the soil borings lacking thick organics (139.45 ft NAVD88, $n=25$). Some of the overlap was caused by the occurrence of a small number of samples in the cypress community on Transect 4 which were subaqueous soils occurring close to the open water of the lake that were very sandy and lacked significant organic accumulation.

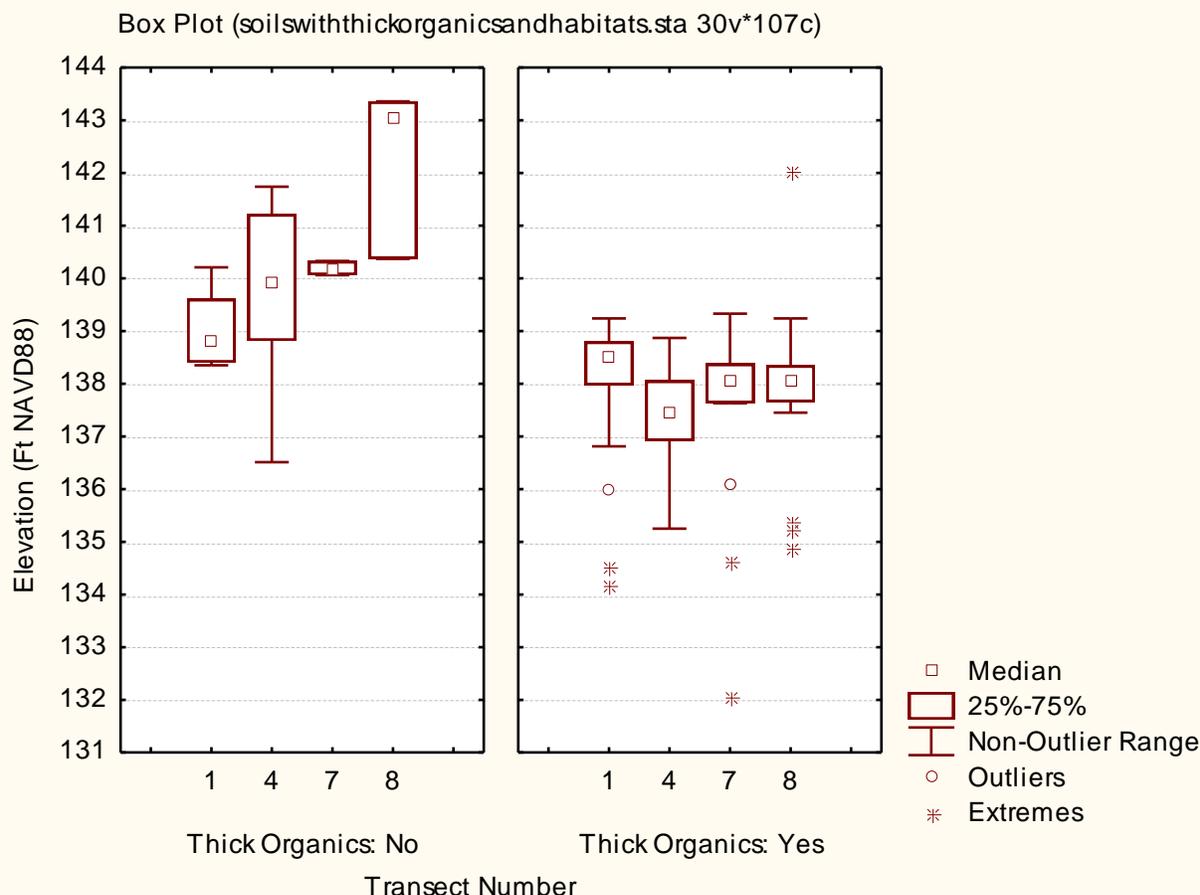
Figure C-2. Elevational distribution by transect of soil borings with thick organics.

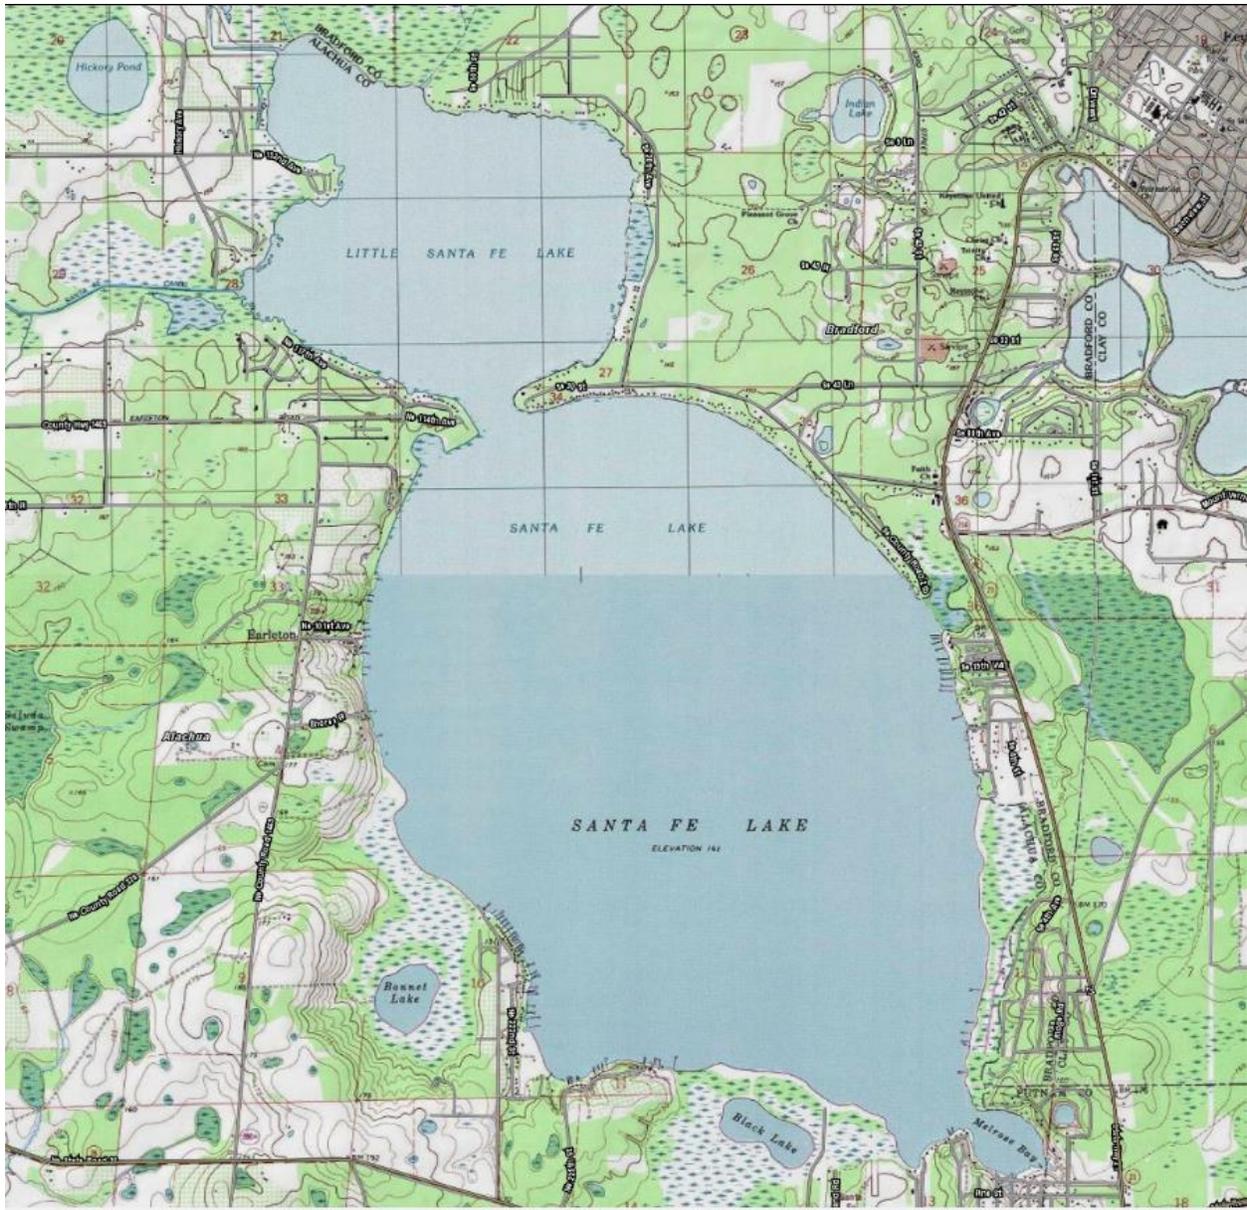
Figure C-5. Topographic Map.

Topographic map features derived from the Web Soil Survey are shown in Figure C-5. The large Santa Fe Swamp, north of the lake, can be seen sloping upland with sharp topographic breaks and low gradient marsh areas.

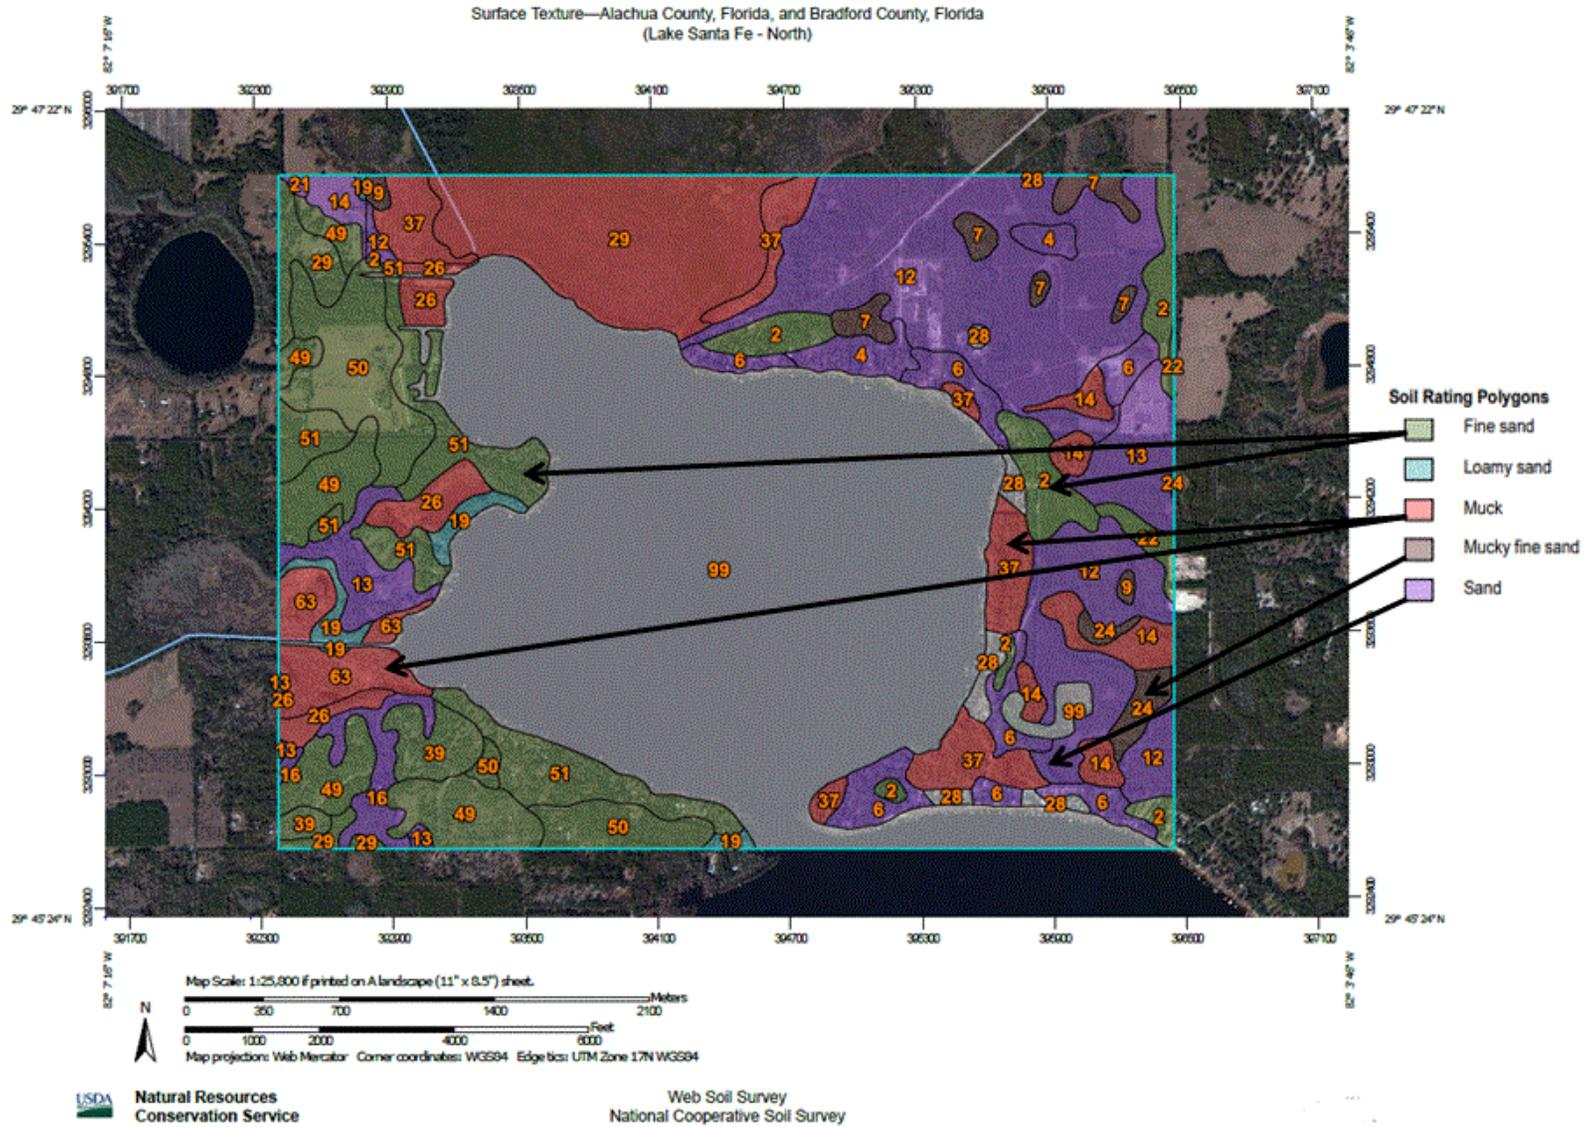
Figure C-10. Soil Surface Texture.

Figure C-10 illustrates the spatial distribution of soil surface texture adjacent to Little Lake Santa Fe. Depth of surface texture can vary depending on occurrence of subsurface layers. Fine sand and muck soils were more prevalent in Alachua County west of the lake, while sandy ridges occurred above the muck soils east of the lake in Bradford County.

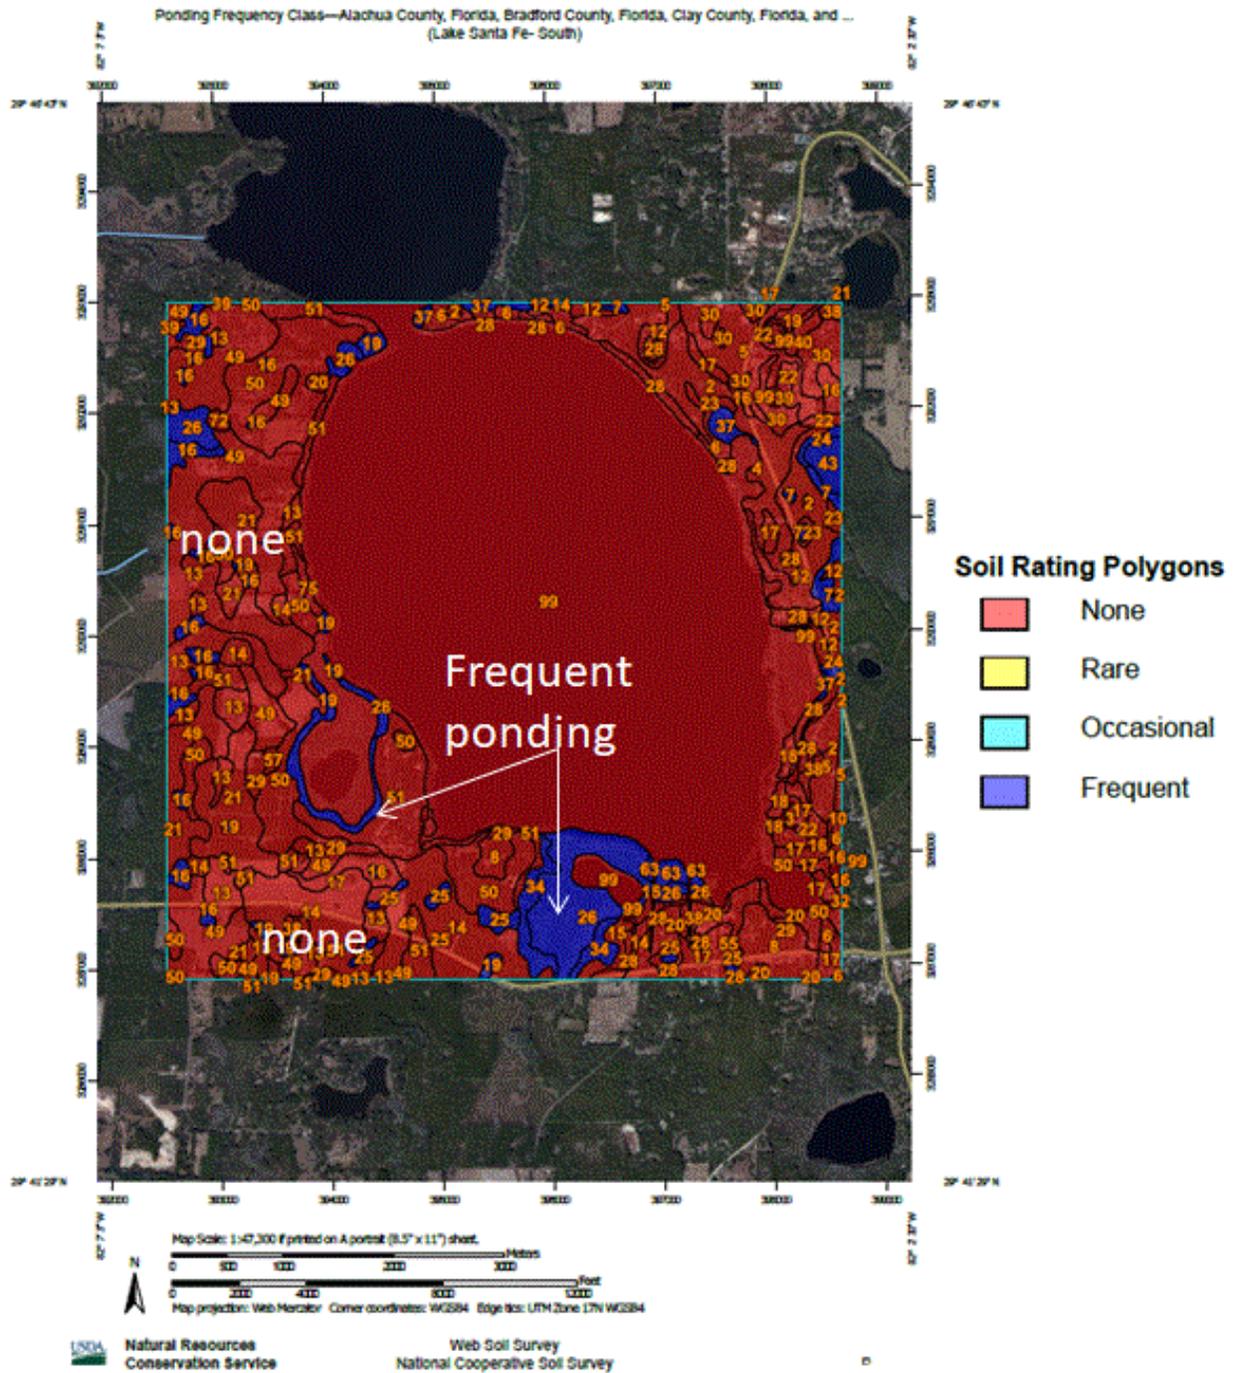
Figure C-12. Ponding Frequency.

Eleven of the 55 soil map units are rated as "frequent" ponding (Figure C-12) giving them a greater than 50% chance in a given year to have standing water above the soil surface. Dominant soils include. Samsula muck (MU 26), Montechoa loamy sand (MU 19), and Surrency sand (MU 16).

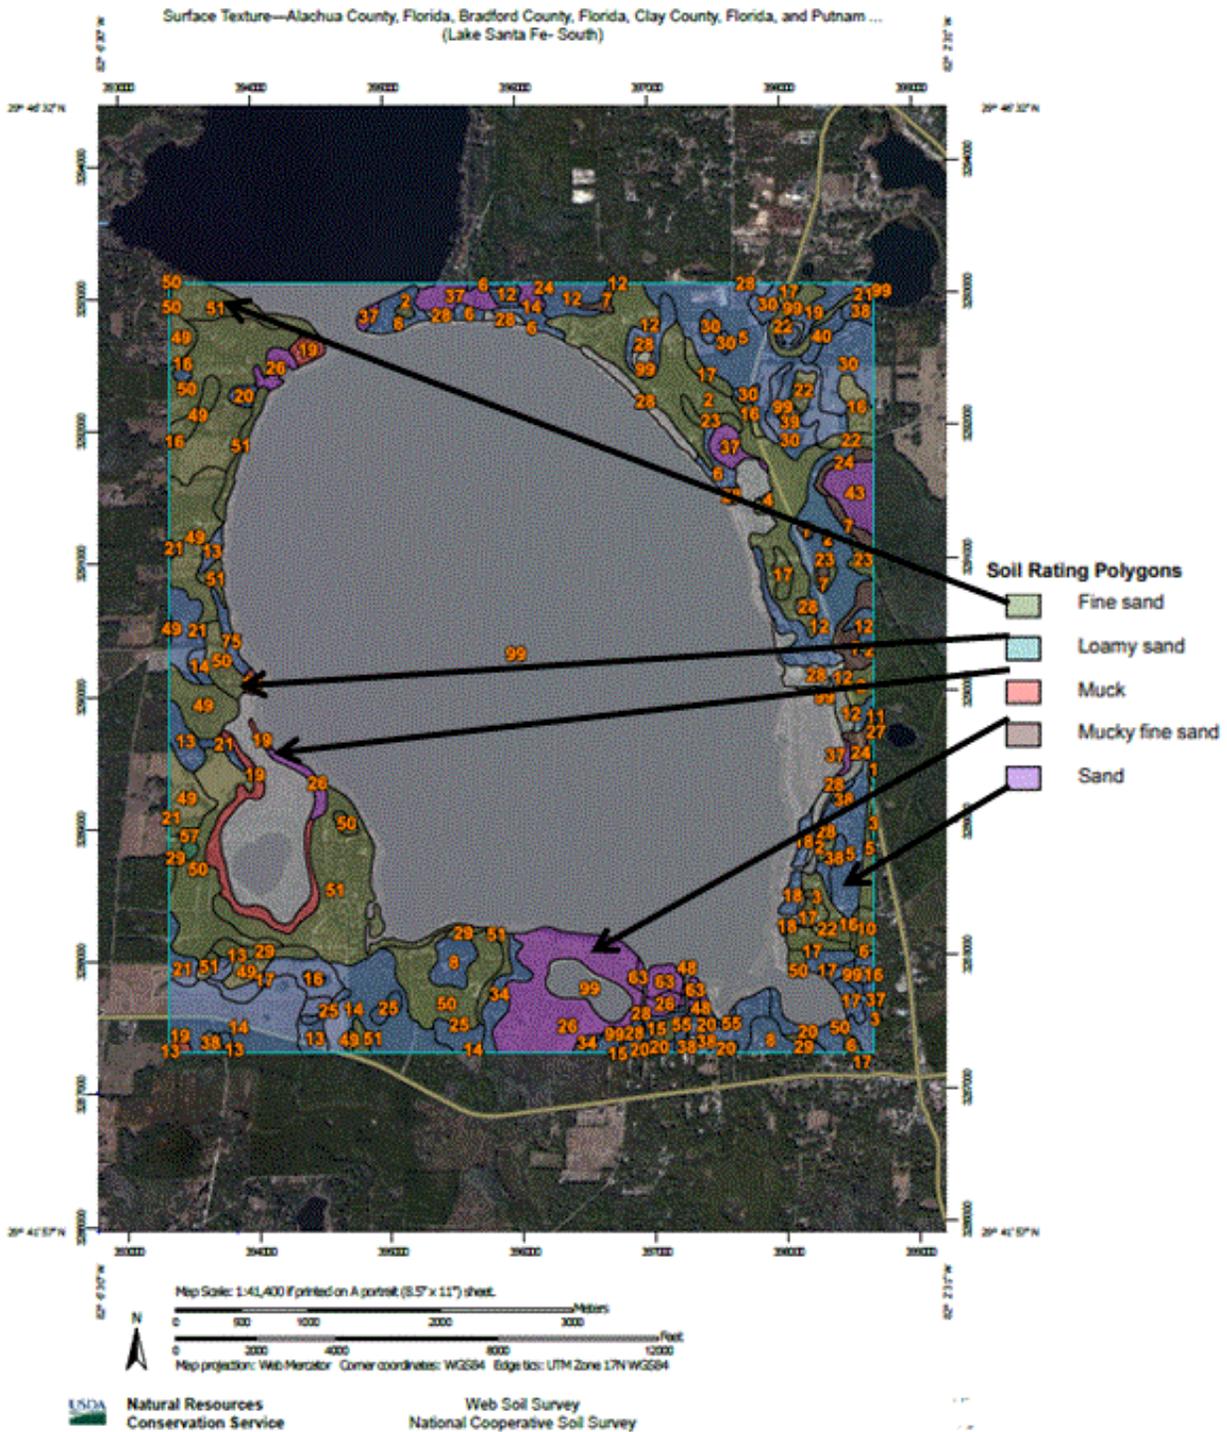
Figure C-13. Soil Surface Texture.

Figure C-13 is a map of soil surface texture. Organic muck soils were most prevalent south of the lake and on the west in Bradford County.

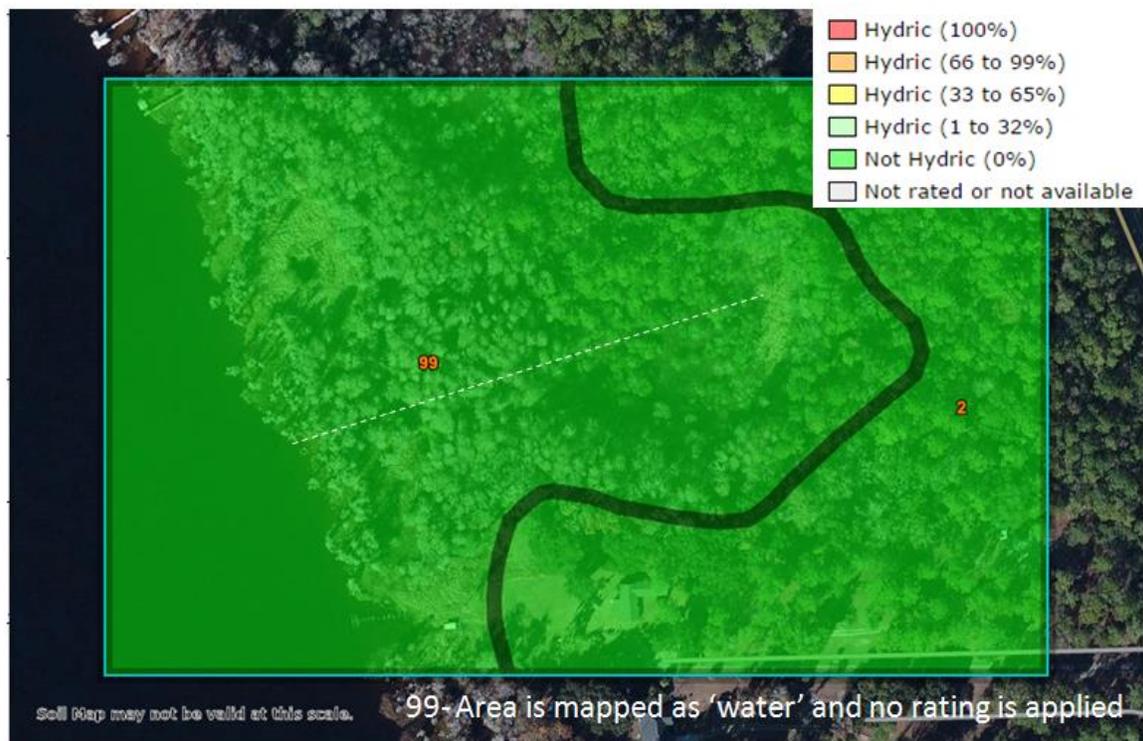
Figure C-21. Hydric Soils for Transect T4.

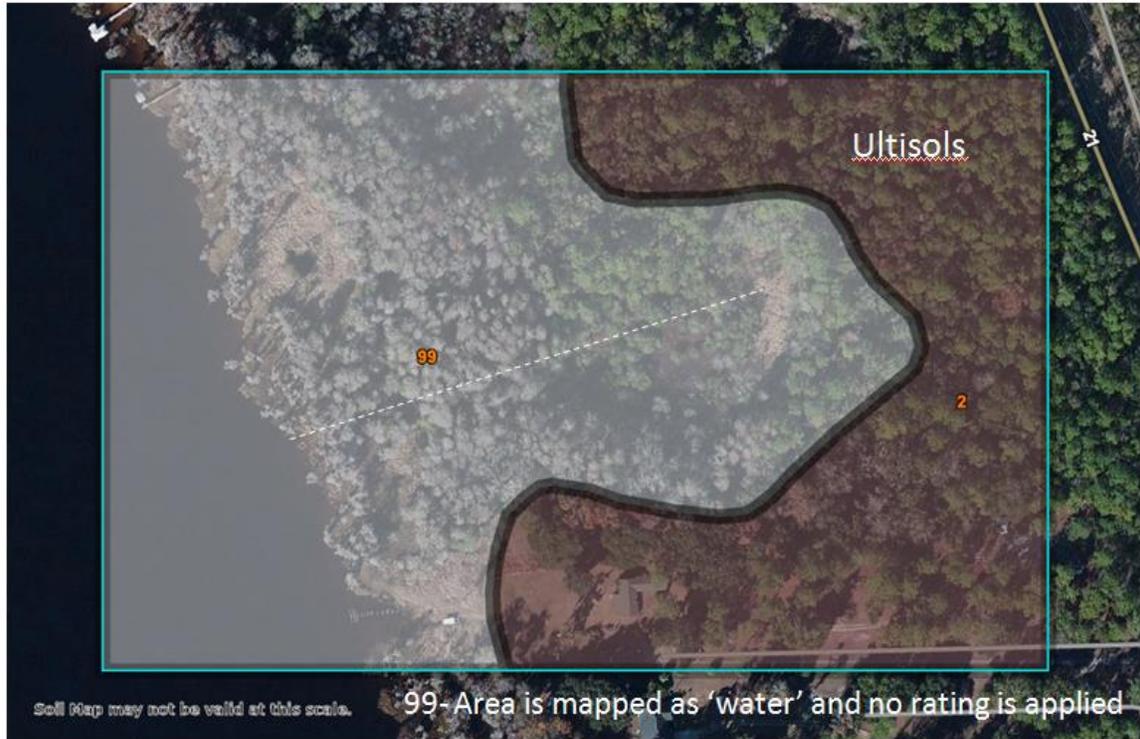
Figure C-22. Soil Orders for Transect T4.

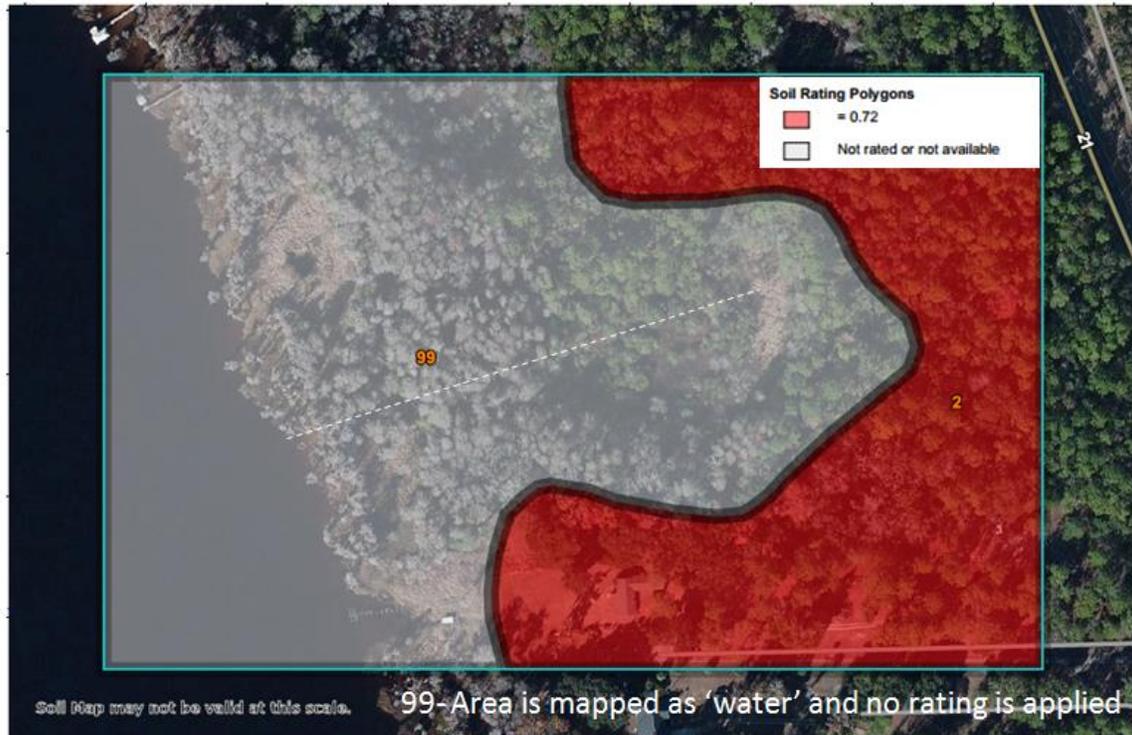
Figure C-24. Soil Organic Matter for Transect T4.

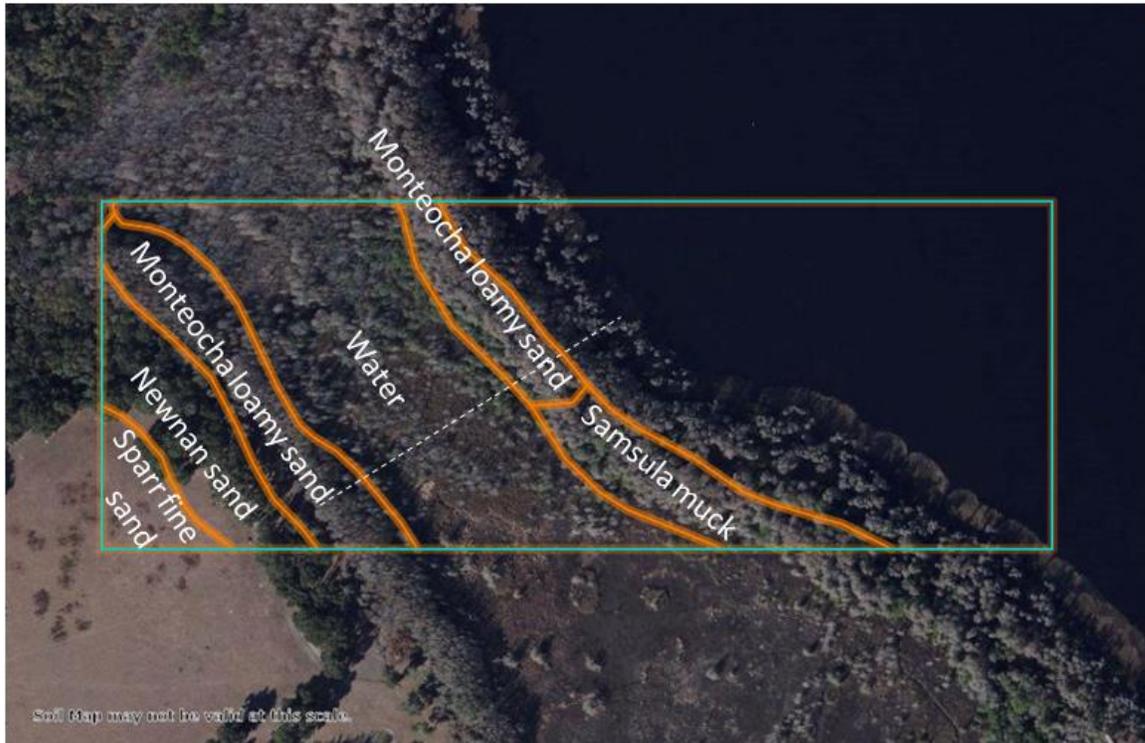
Soils described on Transect T7 are shown in Figure C-25. Soils mapped by the USDA show Monteccha loamy sand (MU 19) in a depressional terrace position above the water's edge close to the lake and rising again below the upland soils Newnan sand (MU 21) and Sparr fine sand (MU 50). Monteccha soils are very poorly drained and frequently pond water. Monteccha loamy sands are classified as sandy, siliceous, hyperthermic Ultic Alaquods. Samsula muck to the south (MU 26) are also very poorly drained soils that frequently pond water and have muck surface layers typically 35 inches thick over sand subsoil. They are Histisols and classified as Sandy or sandy-skeletal, siliceous, dysic, hyperthermic Terric Haplosaprists.

Figure C-25. Soil Map Units Across Transect T7.
