MINIMUM RECOMMENDED LAKE LEVELS: LAKE SANTA FE, FLORIDA

November 2022

Suwannee River Water Management District
9225 County Road 49
Live Oak, FL 32060

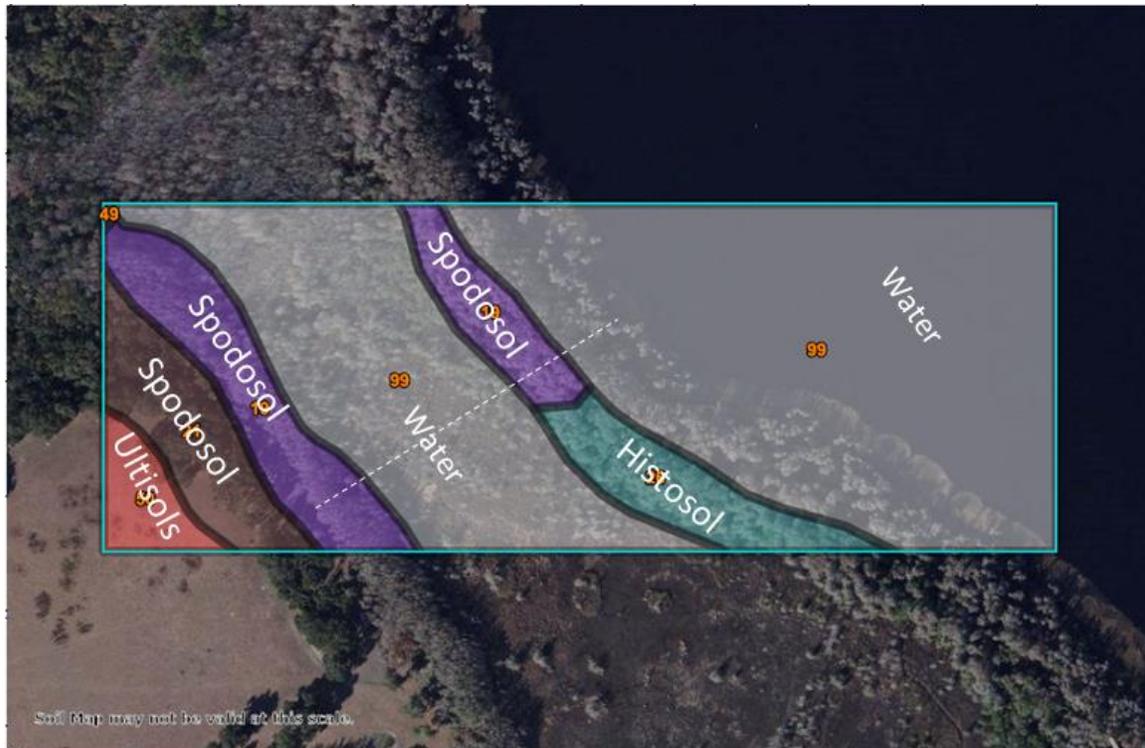
Figure C-27. Soil Orders for Transect T7.

Figures C-26 through C-29 provide interpretive maps for Transect T7 and surrounding uplands depicting area influential landscapes. Monteccha soils are Spodosols with a dark rich organic subsoil, unlike the Samsula muck which is a Histisol. Other maps illustrate hydric soil ratings, soil ecological site name, and soil organic matter content typical for the soil map units.

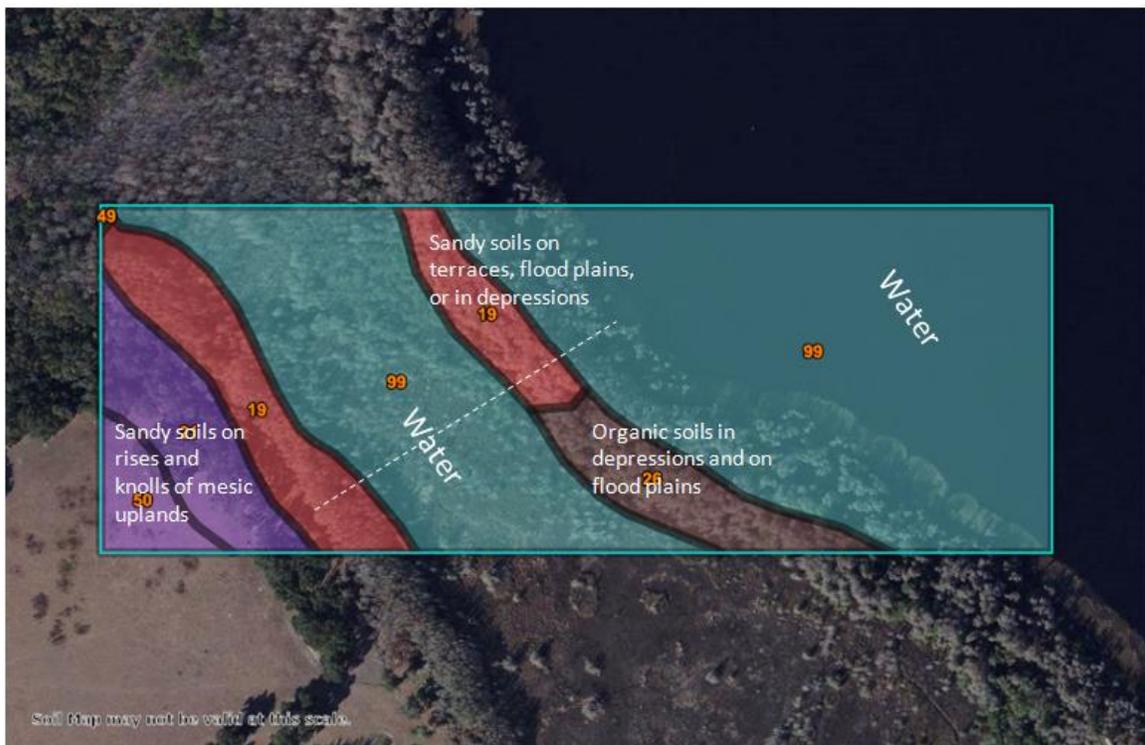
Figure C-28. Soil Ecological Site Name for Transect T7.

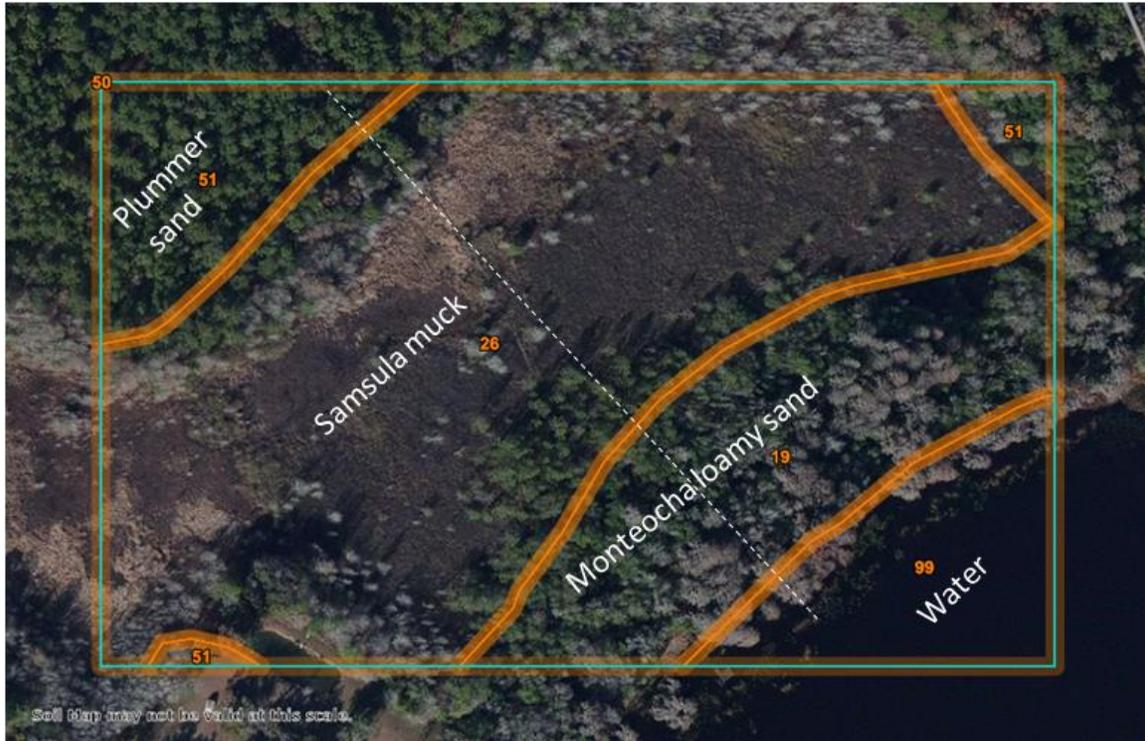
Montecocha soils are very poorly drained and frequently pond water and are classified as sandy, siliceous, hyperthermic Ultic Alaquods. Samsula muck soils to the west (MU 26) also are very poorly drained and frequently pond water and have muck surface layers typically 35 inches thick over sand subsoil. They are Histosols and classified as Sandy or sandy-skeletal, siliceous, dysic, hyperthermic Terric Haplosaprists. Plummer sand soils upslope on the flats are typically non-hydric with seasonal high saturation (SHS) at six to 18 inches below the soil surface. Plummer soils are classified as Loamy, siliceous, subactive, thermic Grossarenic Paleaquults.

Figure C-30. Soil Map Units Across Transect T8.

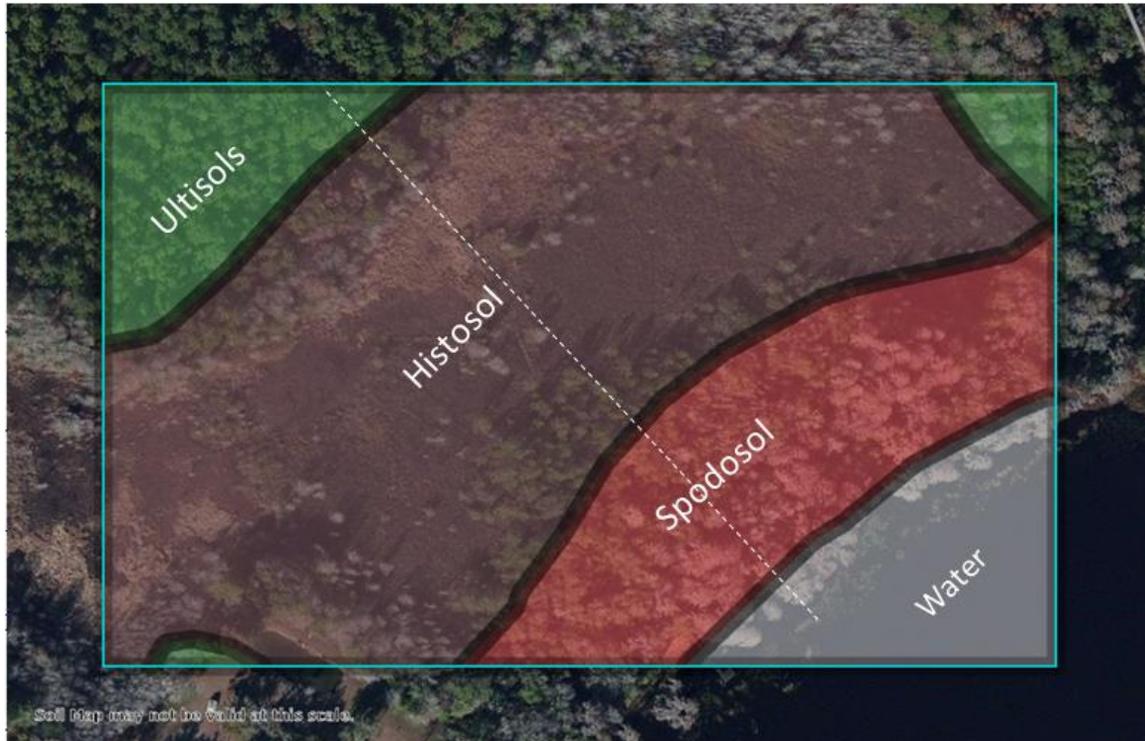
Figure C-32. Soil Orders for Transect T8.

Figures C-31 through C-34 provide interpretive maps for Transect T8 and surrounding uplands depicting area influential landscapes. These maps illustrate hydric soil ratings, soil ecological site name, and soil organic matter content typical for the soil map units.

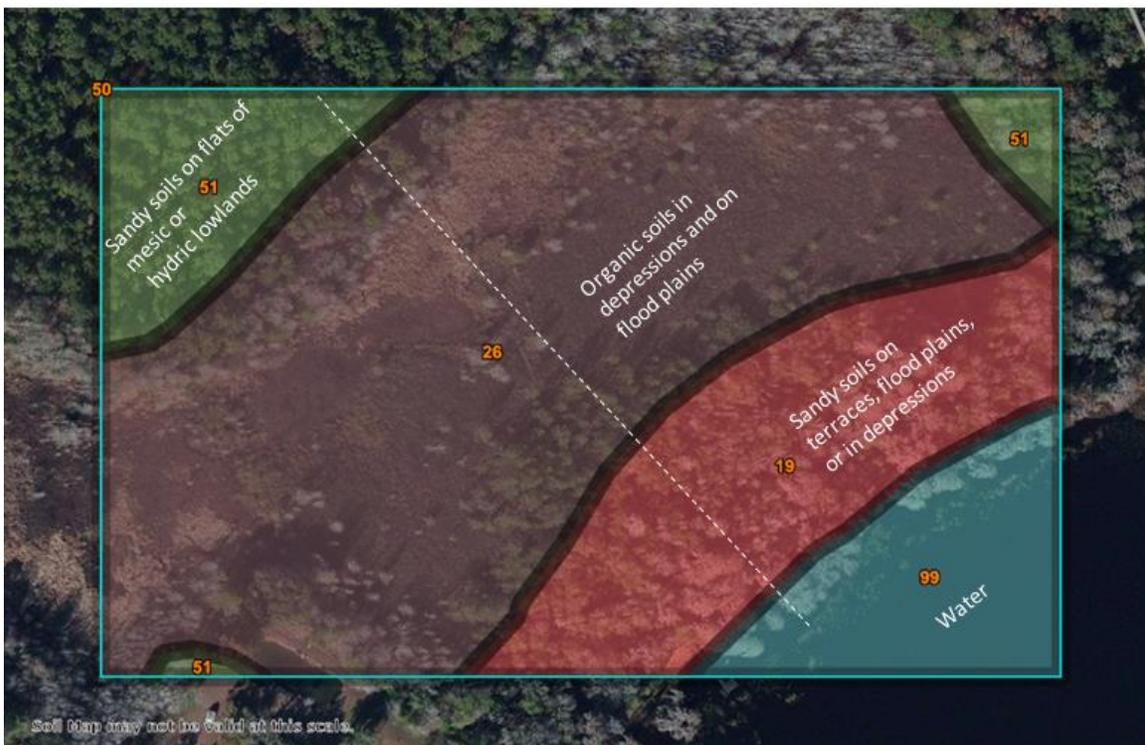
Figure C-33. Soil Ecological Site Name for Transect T8.

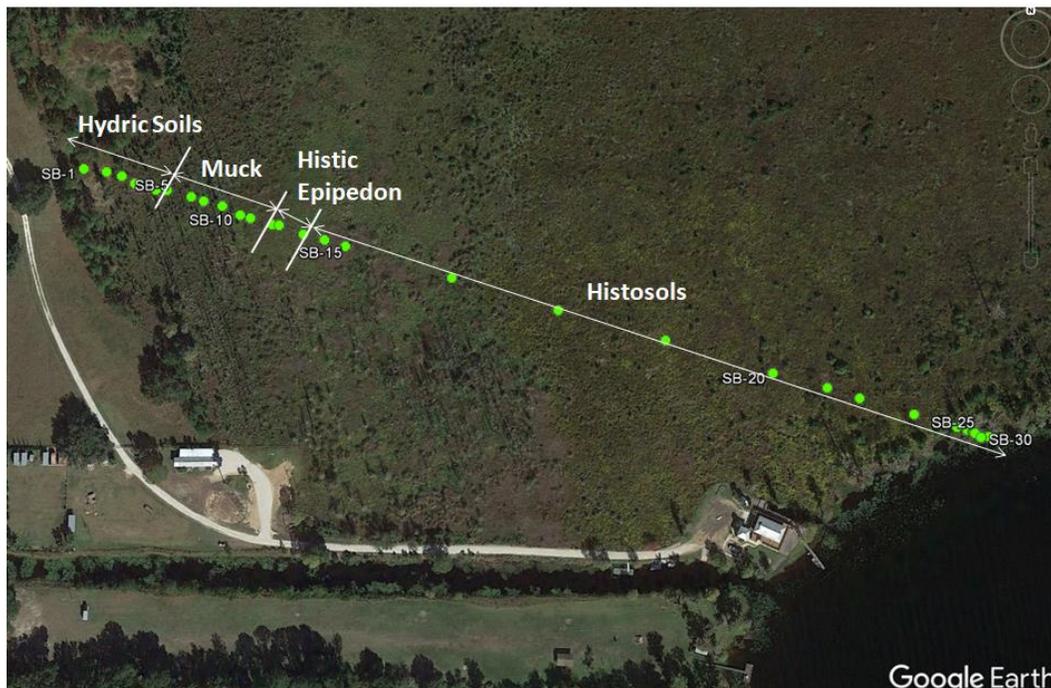
Figure C-35. Transect T1- Soil Boring Locations and Limits of Organic Soils.

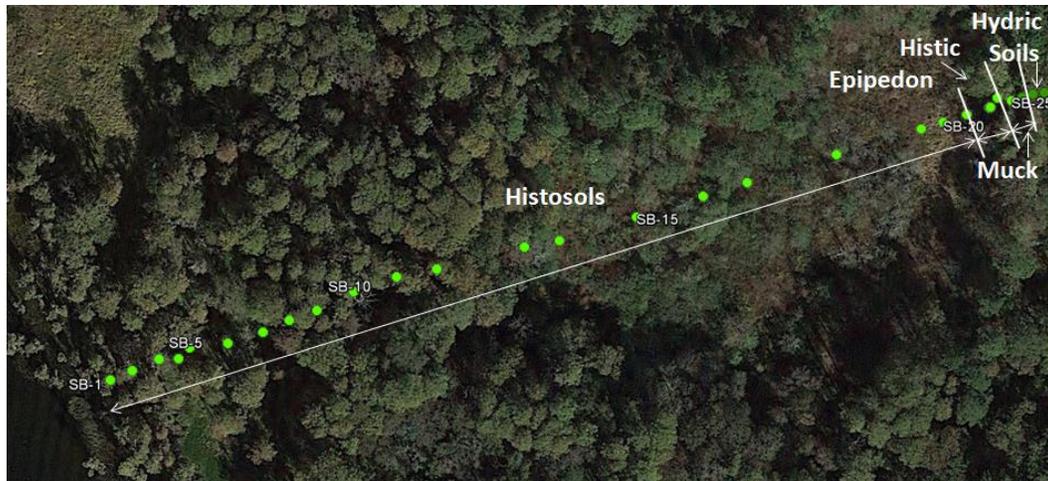
Figure C-36. Transect T4 - Soil Boring Locations and Limits of Organic Soils.

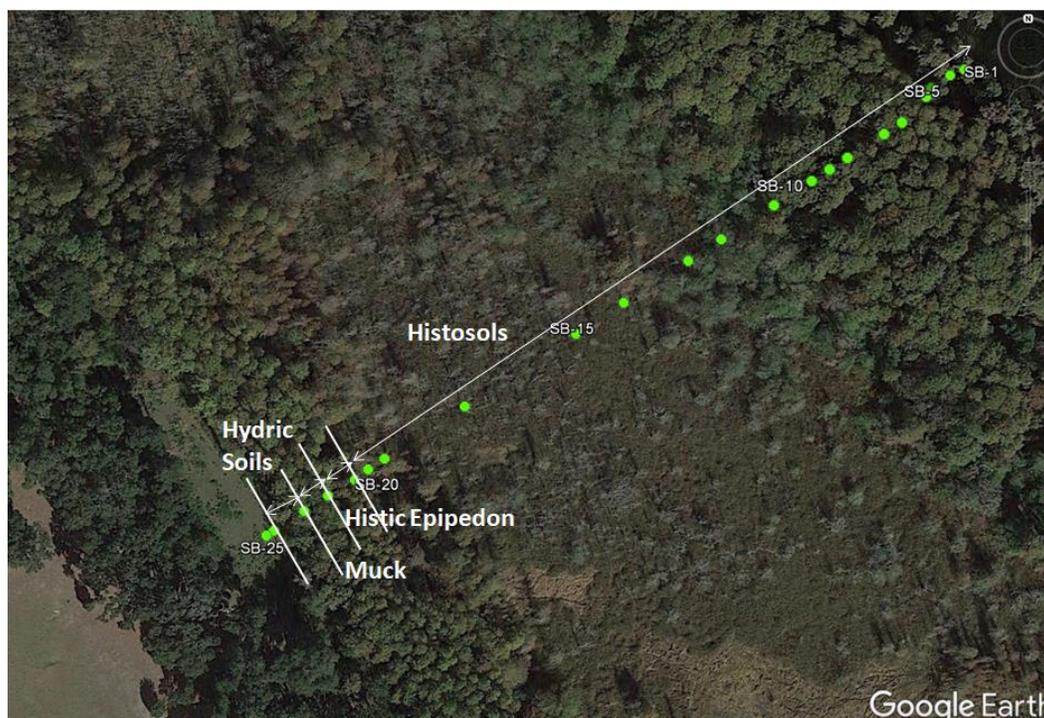
Figure C-37. Transect T7 - Soil Boring Locations and Limits of Organic Soils.

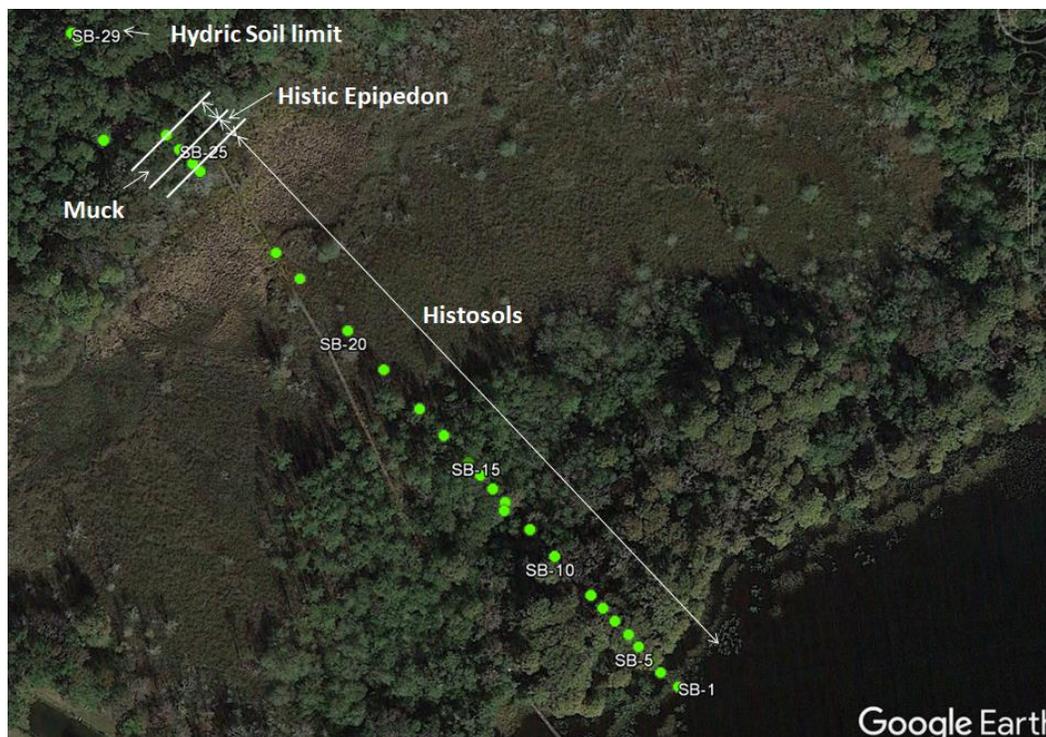
Figure C-38. Transect T8 - Soil Boring Locations and Limits of Organic Soils.
